TECHNICAL PUBLICATIONS, STI'S, SI'S & COMMAND
MAINTENANCE INSTRUCTIONS
JAN. - JUNE 1947

TECHNICAL SUBSTITUTIONS & DRAWINGS
NAPIER 500 H.P. & LA LION ENGINES

Attached for your information is a copy of S.T.I./Spitfire/51.

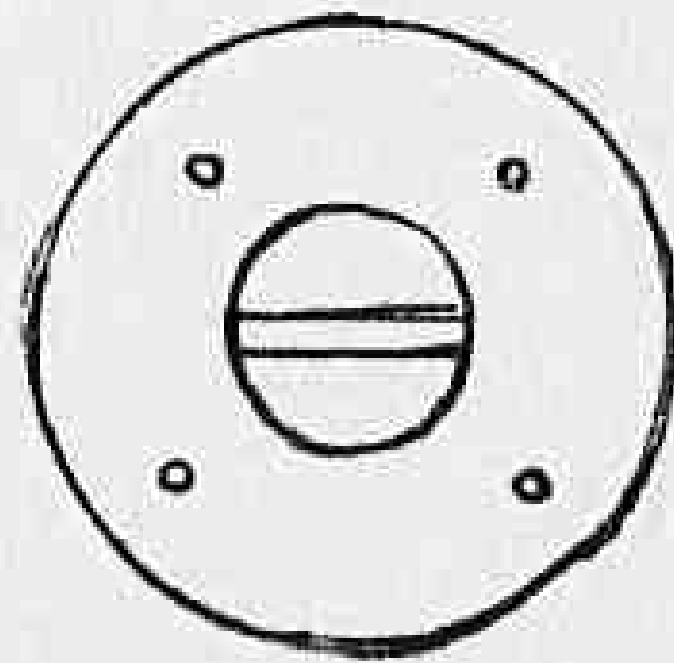
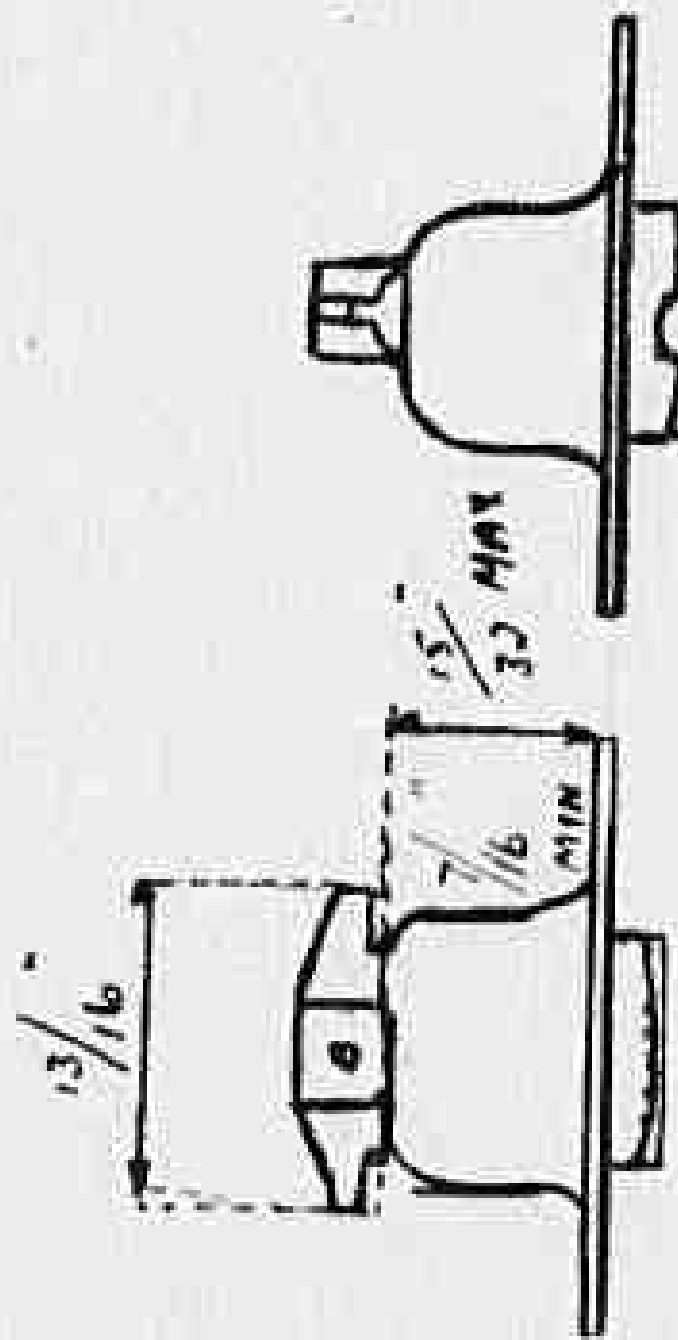
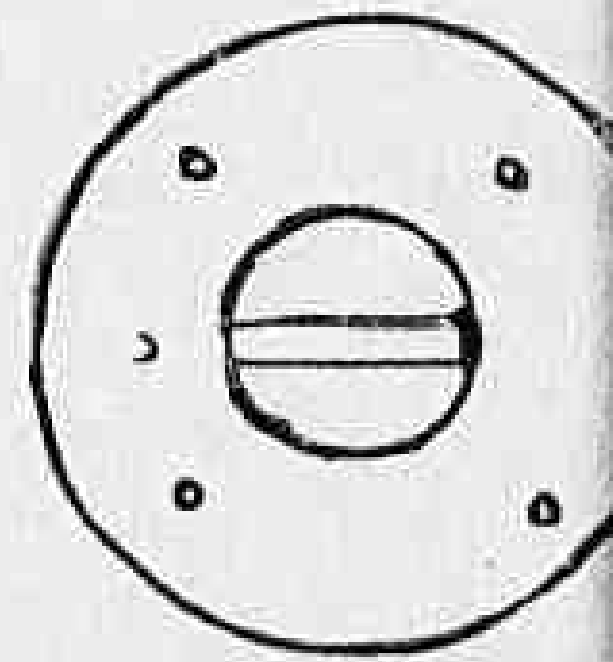
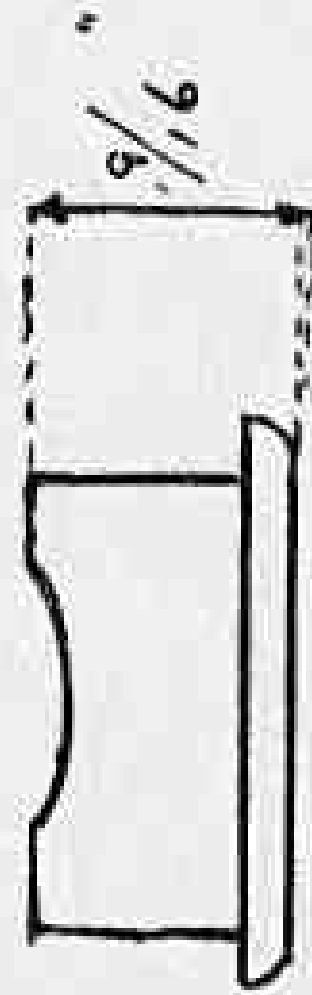
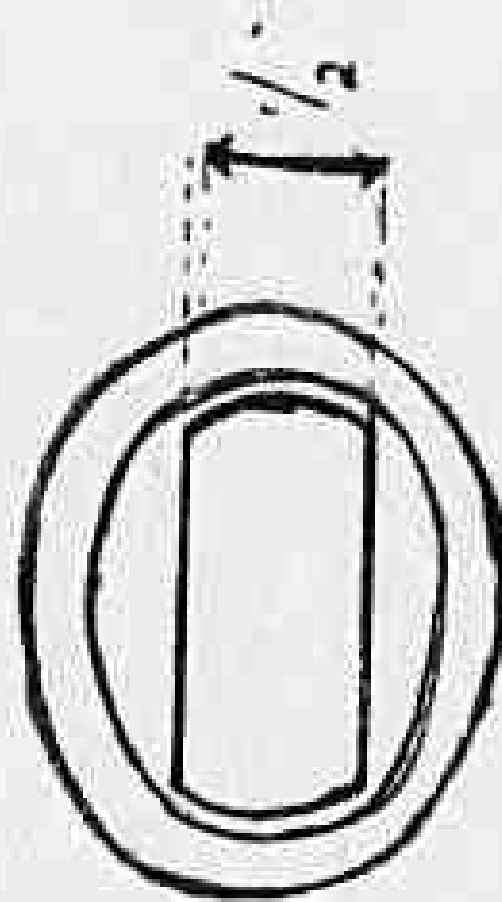
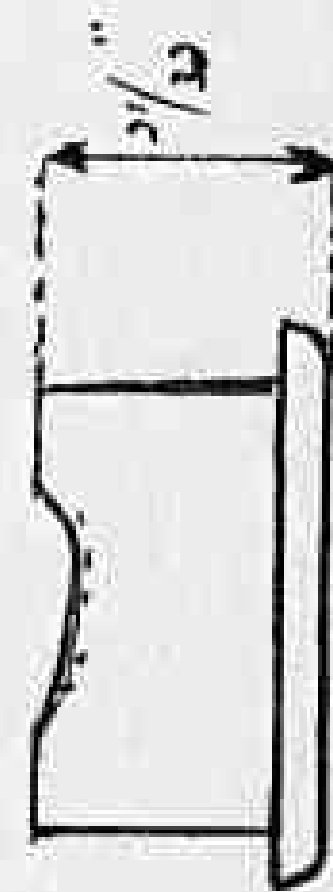
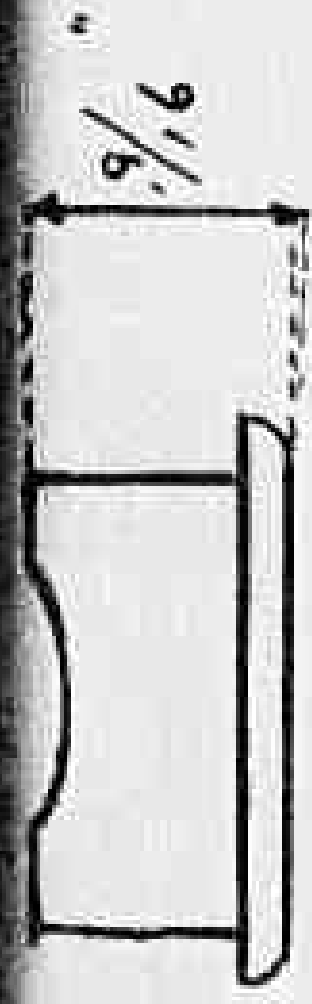
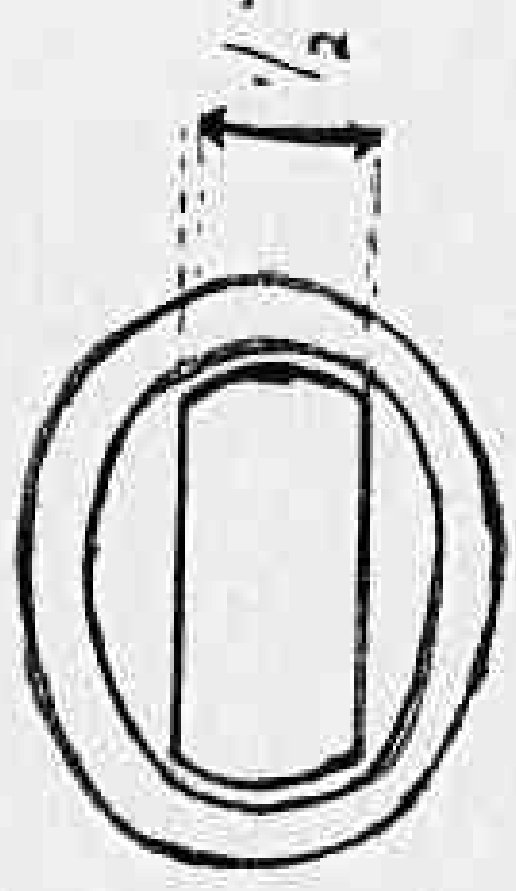
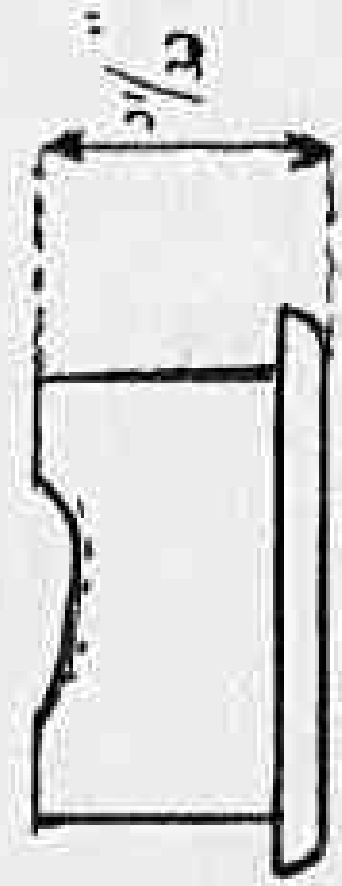
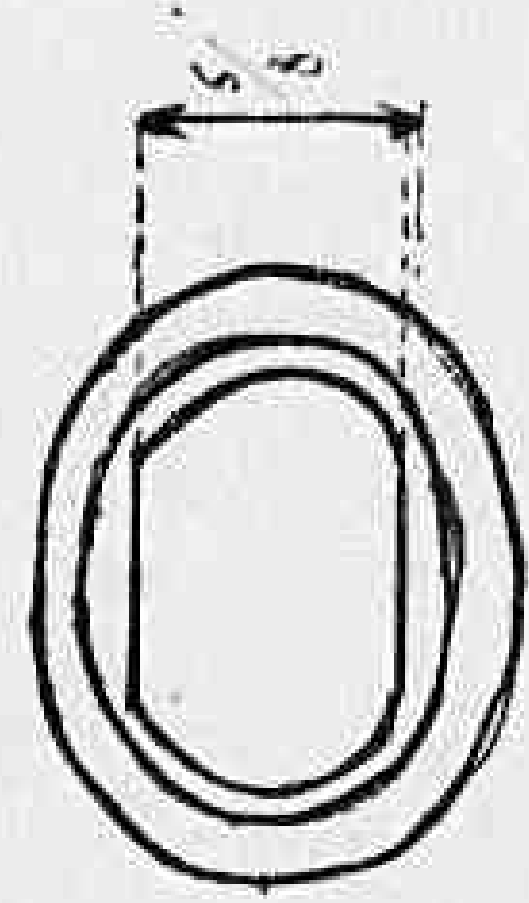
STI / SPITFIRE / SI
STI / SEAFIRE / 43A

A fatal accident has occurred which is believed to be due to a misalignment of the engine cooling fans occurring away in flight. Investigation has shown that the sockets for some of the power type cooling fasteners were of incorrect size which caused the misalignment to withdraw from the socket although generally correctly designed. There are two combinations of fasteners and sockets affected, although of the same basic design, differ slightly in construction and dimensions (see attached sketch). The combination of fastener and socket with the same dimensions is listed in Appendix A, 1, 2, 3, 4, 5, 6, 7, 8, 9, and 10 and is fitted to all engines fitted with the power type cooling fasteners. It is essential that the combinations of fasteners and sockets are those in the attached sketch and preserved as such.

(4) During investigation it was discovered that certain cowling fasteners, usually fitted complete with fastener sockets, had been fitted with the incorrect size socket. All fasteners, sockets and fastener heads as shown in the attached Sections are to be examined and action taken to ensure that only the correct combinations can be fitted as replacements.

- (1) Not later than 15th August 1944, all aircraft as in Para. (1) are to be examined to ensure that the combinations of fasteners and sockets fitted, are as shown in attached sketch. Power plants are to be examined as soon as possible but before issue. Where discrepancies are found immediate rectification action is to be taken.
- (2) Having investigated on 14th August 1944, the discrepancy that occurs in cooling fans, usually fitted engine cooling fans with fastener sockets, had been fitted with the incorrect size socket. All cooling, sockets and fasteners held in engines in the engine sections are to be examined and action taken as soon as possible. The combinations are to be fitted as recommended.

(3) Not later than next Daily Inspection, all airplanes as in Para. (1) are to be examined to ensure that the combinations of fasteners and sockets fitted, are as shown in attached sketch. Where plans are to be examined as soon as possible but before issue. Where discrepancies are found immediate replacement action is to be taken.

NOTE 2. In view of the varying amounts of wear which may have taken place, it is appreciated that measurement of the fasteners and sockets on aircraft in use to any specific degree of accuracy would be difficult. The dimensions on the drawings are therefore IIC manufacturing dimensions but were obtained by measurement of actual fasteners and sockets and are only quoted as a guide. It is considered that the visual differences between the two combinations is pronounced enough to allow more accurate measurement unnecessary.
