HEADQUARTERS, ALLIED COMMISSION

TRANSPORTATION SUB-COMMISSION

POINT REPORT

MARSALA SICILY

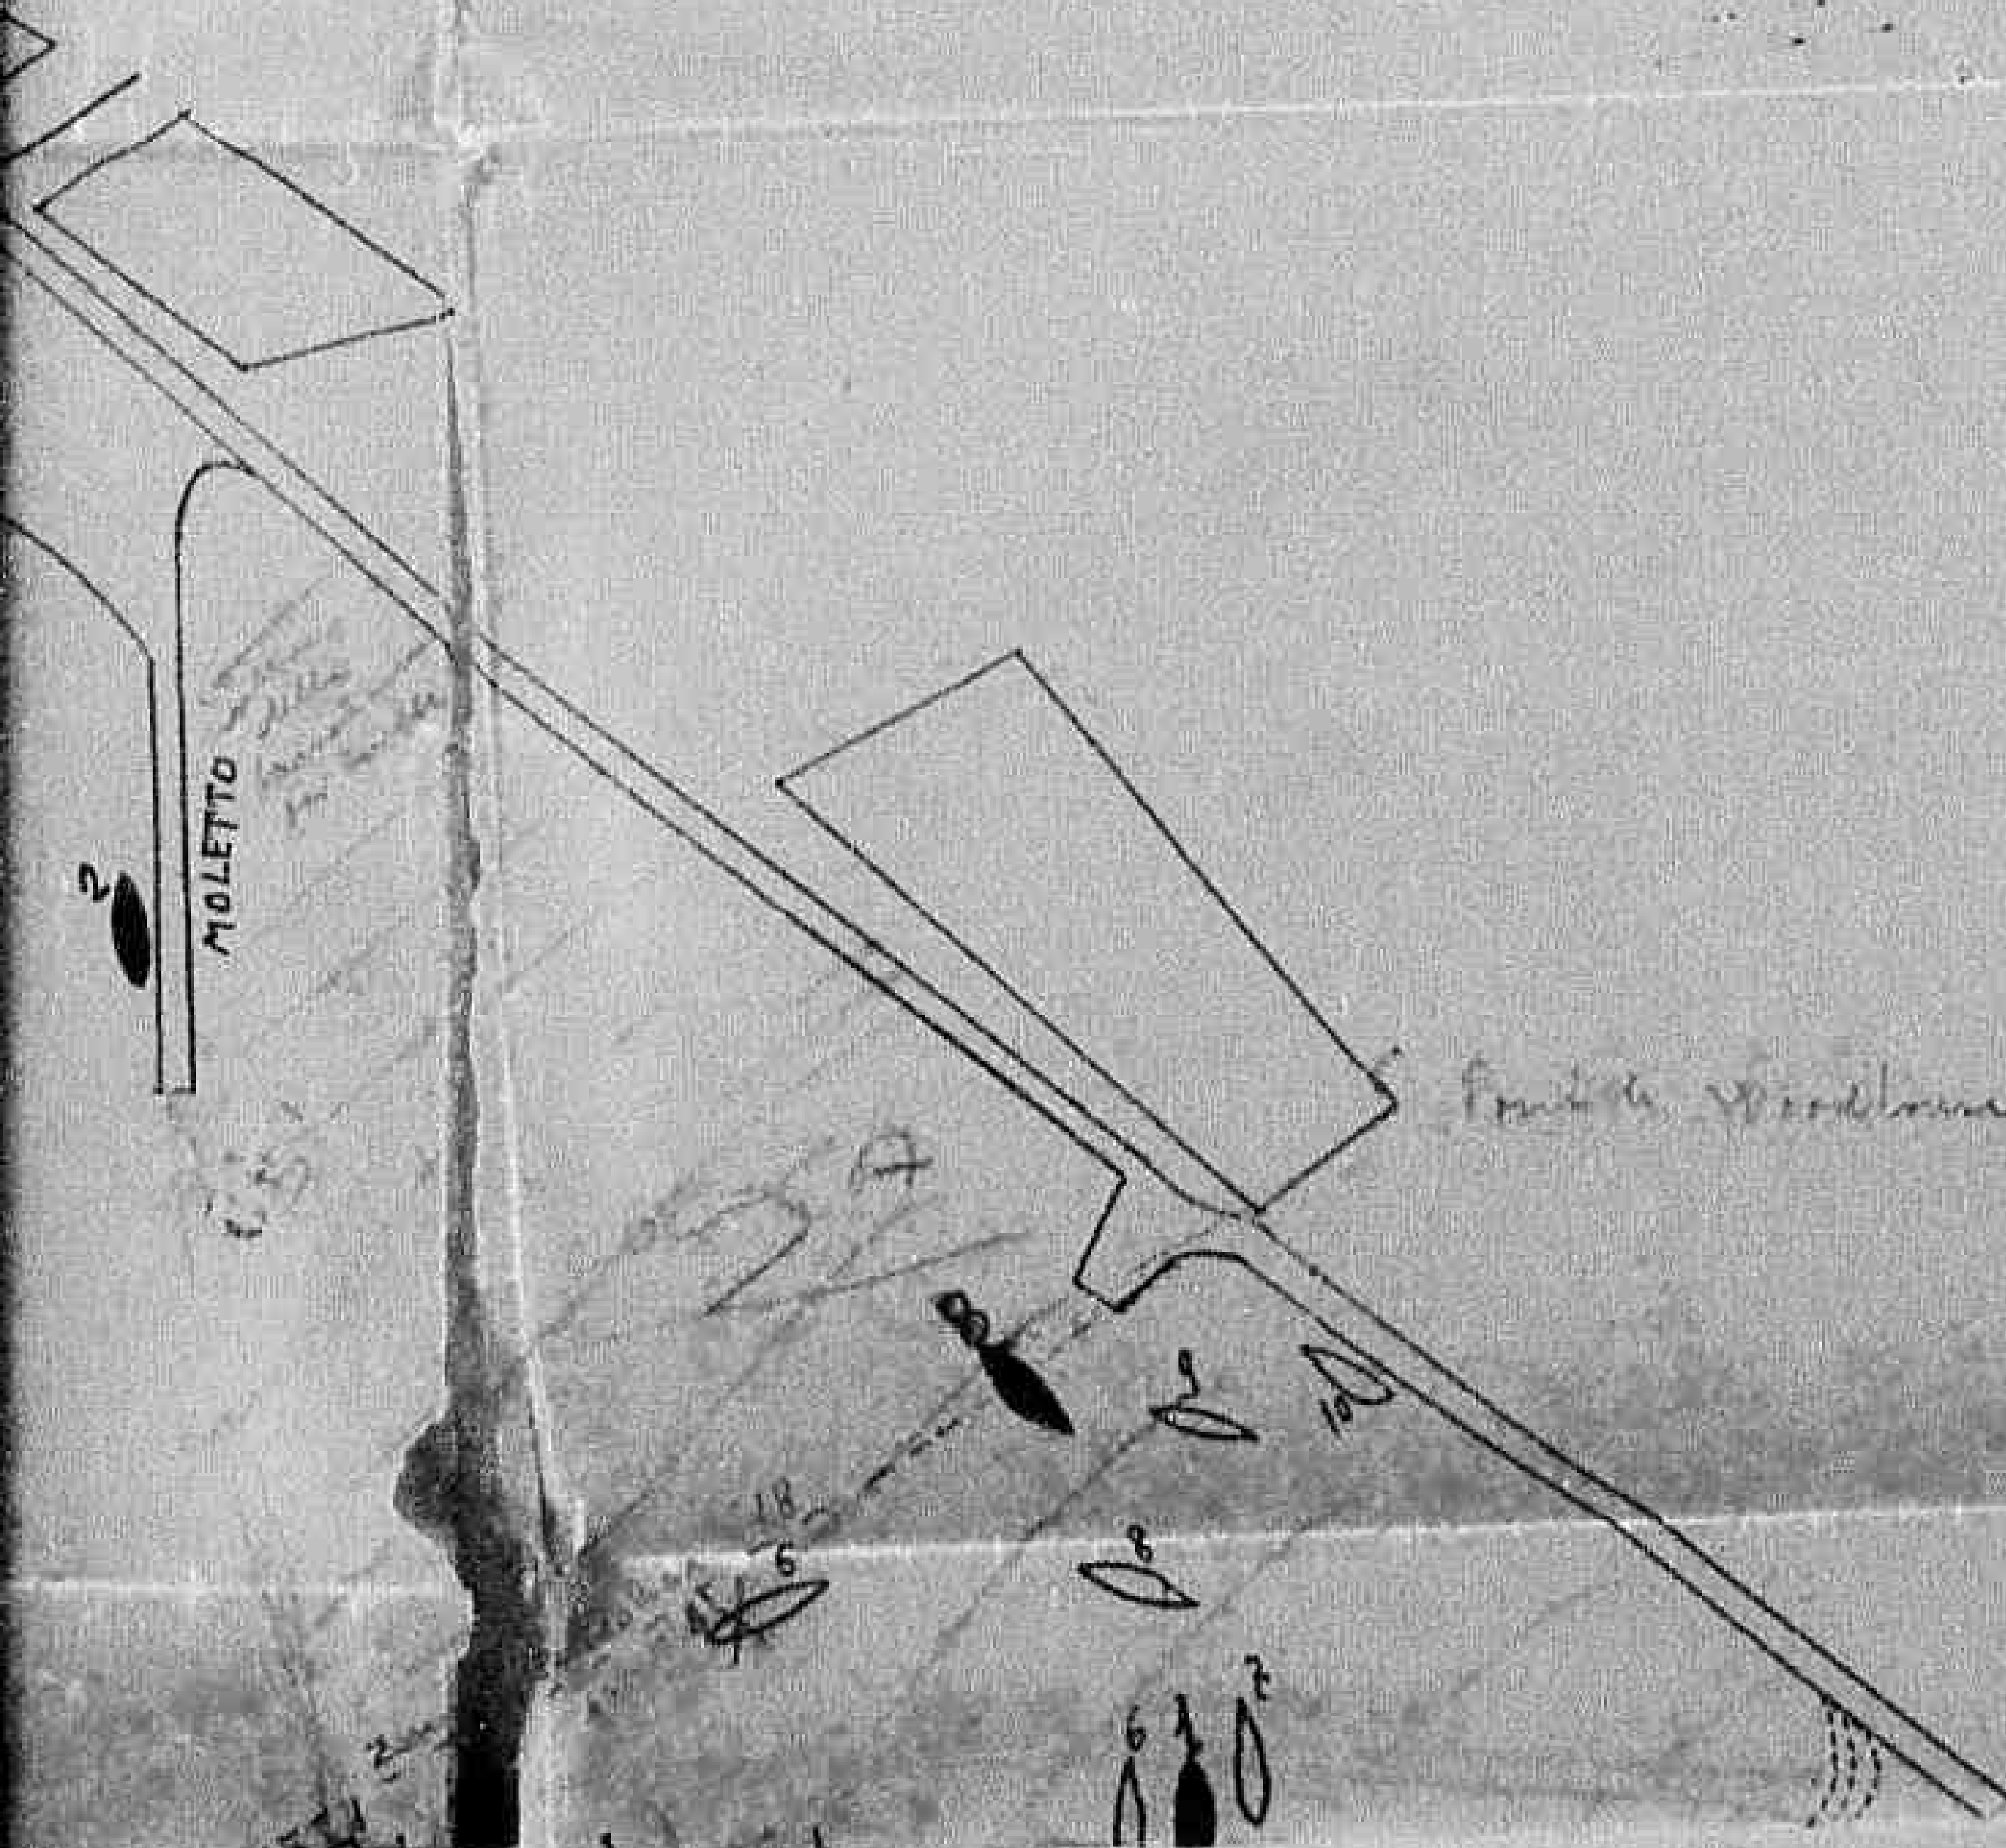
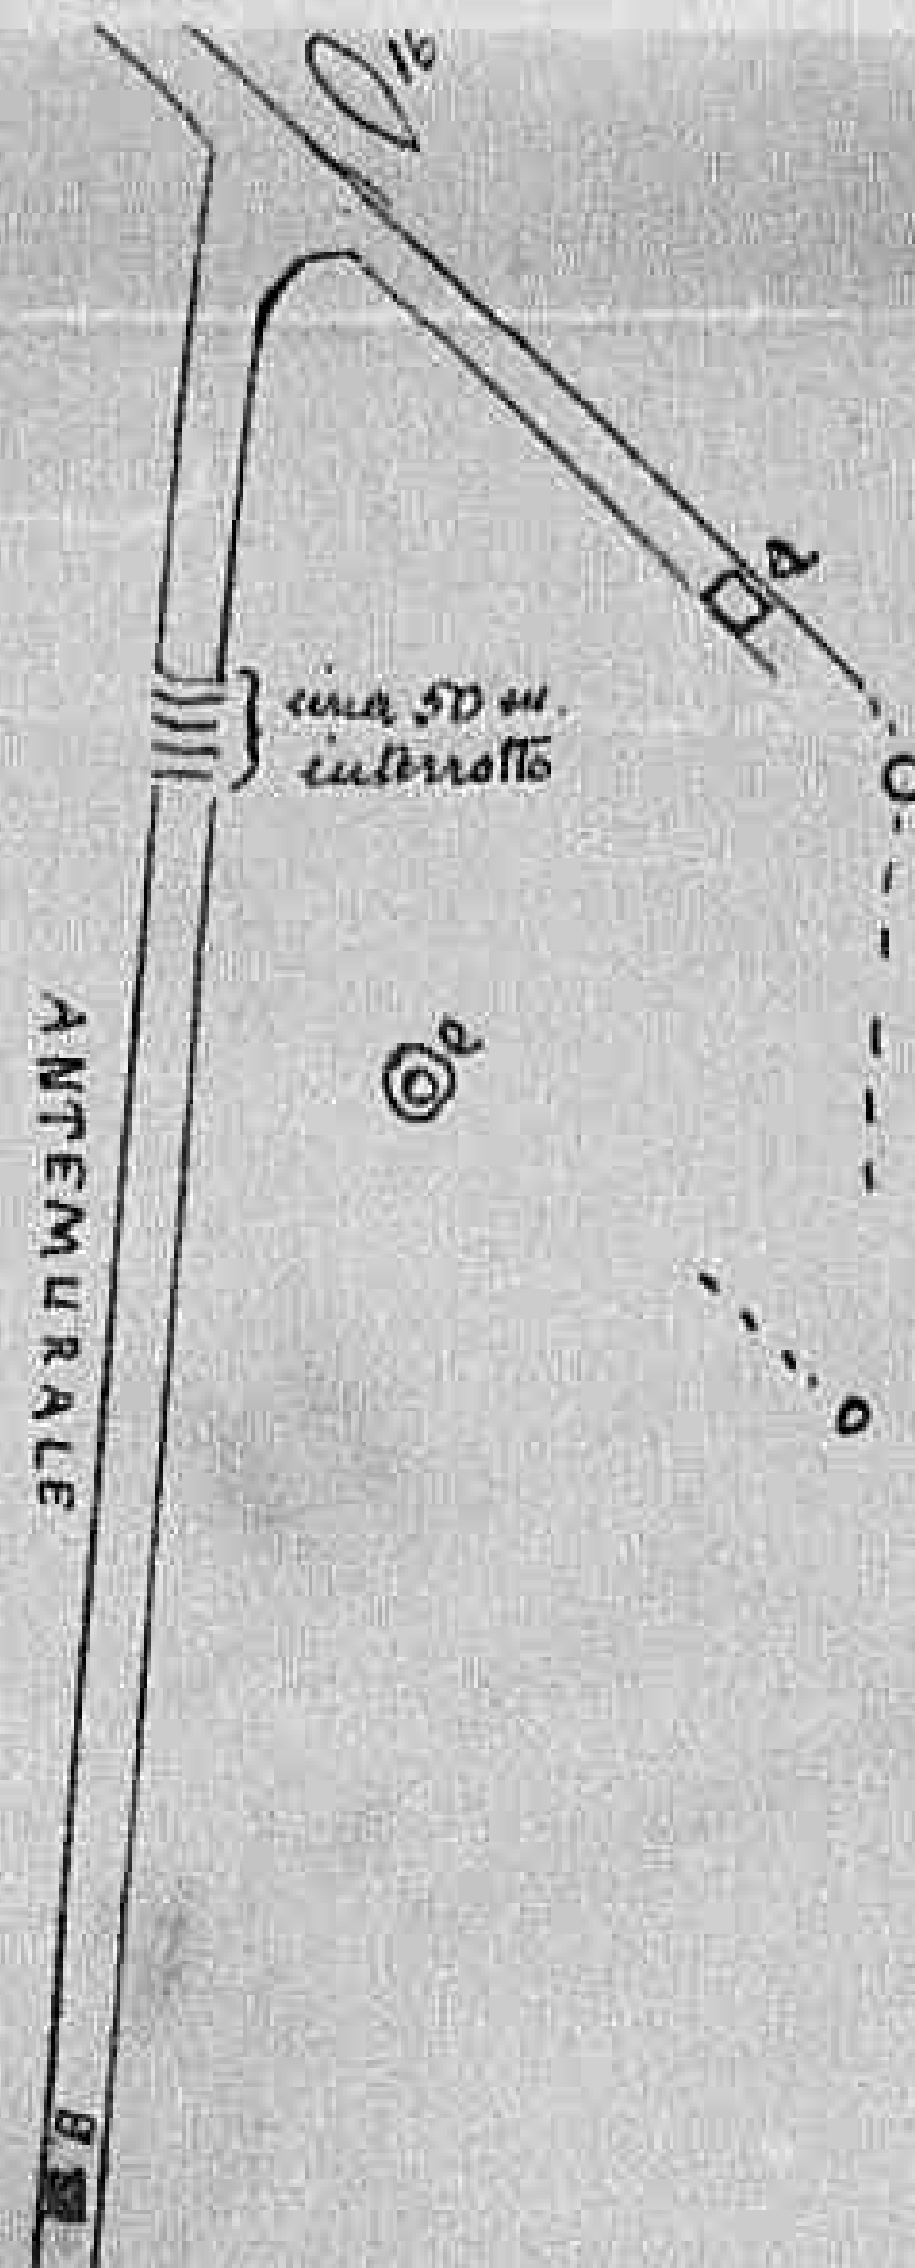
Pianta del Porto di Marsala

○ dal n. 1 al n. 5 moto zattera tedesche di ferro

n. 6 m/r Stelvio in ferro

n. 7 m/r Gilda in legno

n. 8 Bettolina in legno

n. 9 Motozattera tedesca in ferro

n. 10 " " " "

n. 11 Bettolina in legno

n. 12 Draga Sardegna

n. 13 Pontoncino sopra acqua

dal n. 14 al n. 16 moto zattere in ferro

n. 17 Bettolina appudate segnate da un puntello

--- n. 18 Zona Pericolosa

● Le unità segnate in rosso sono state già recuperate

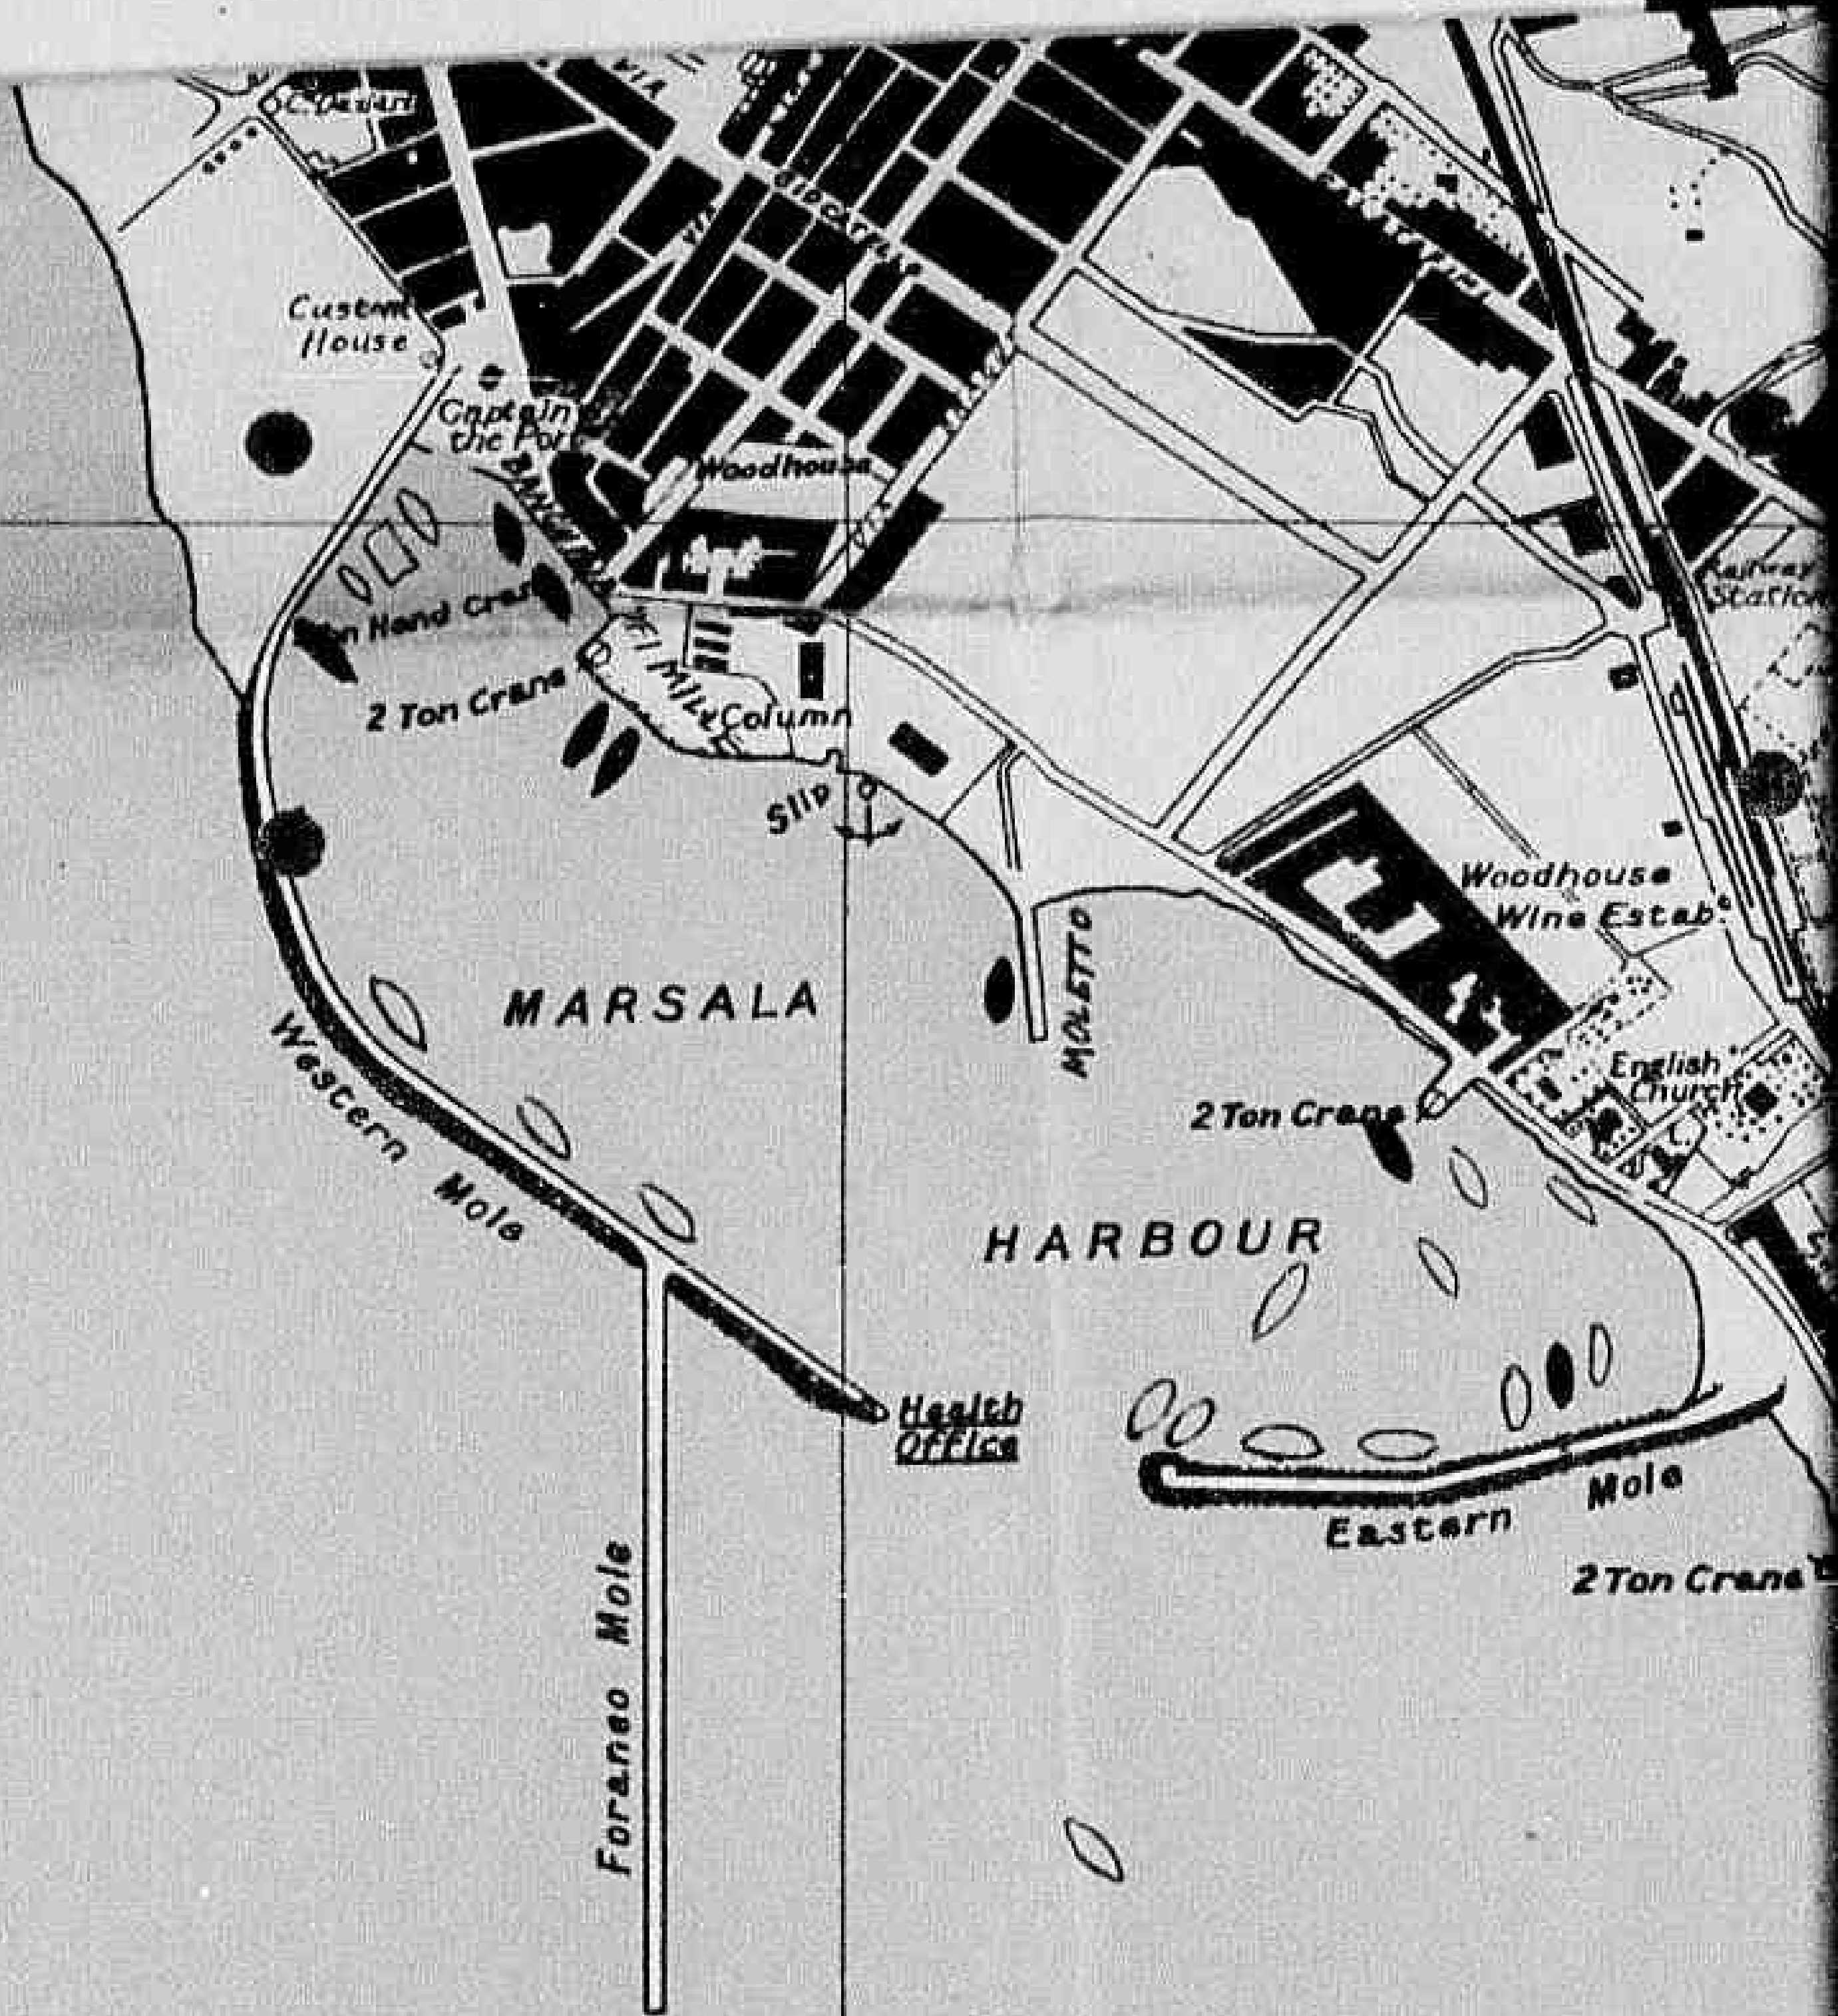
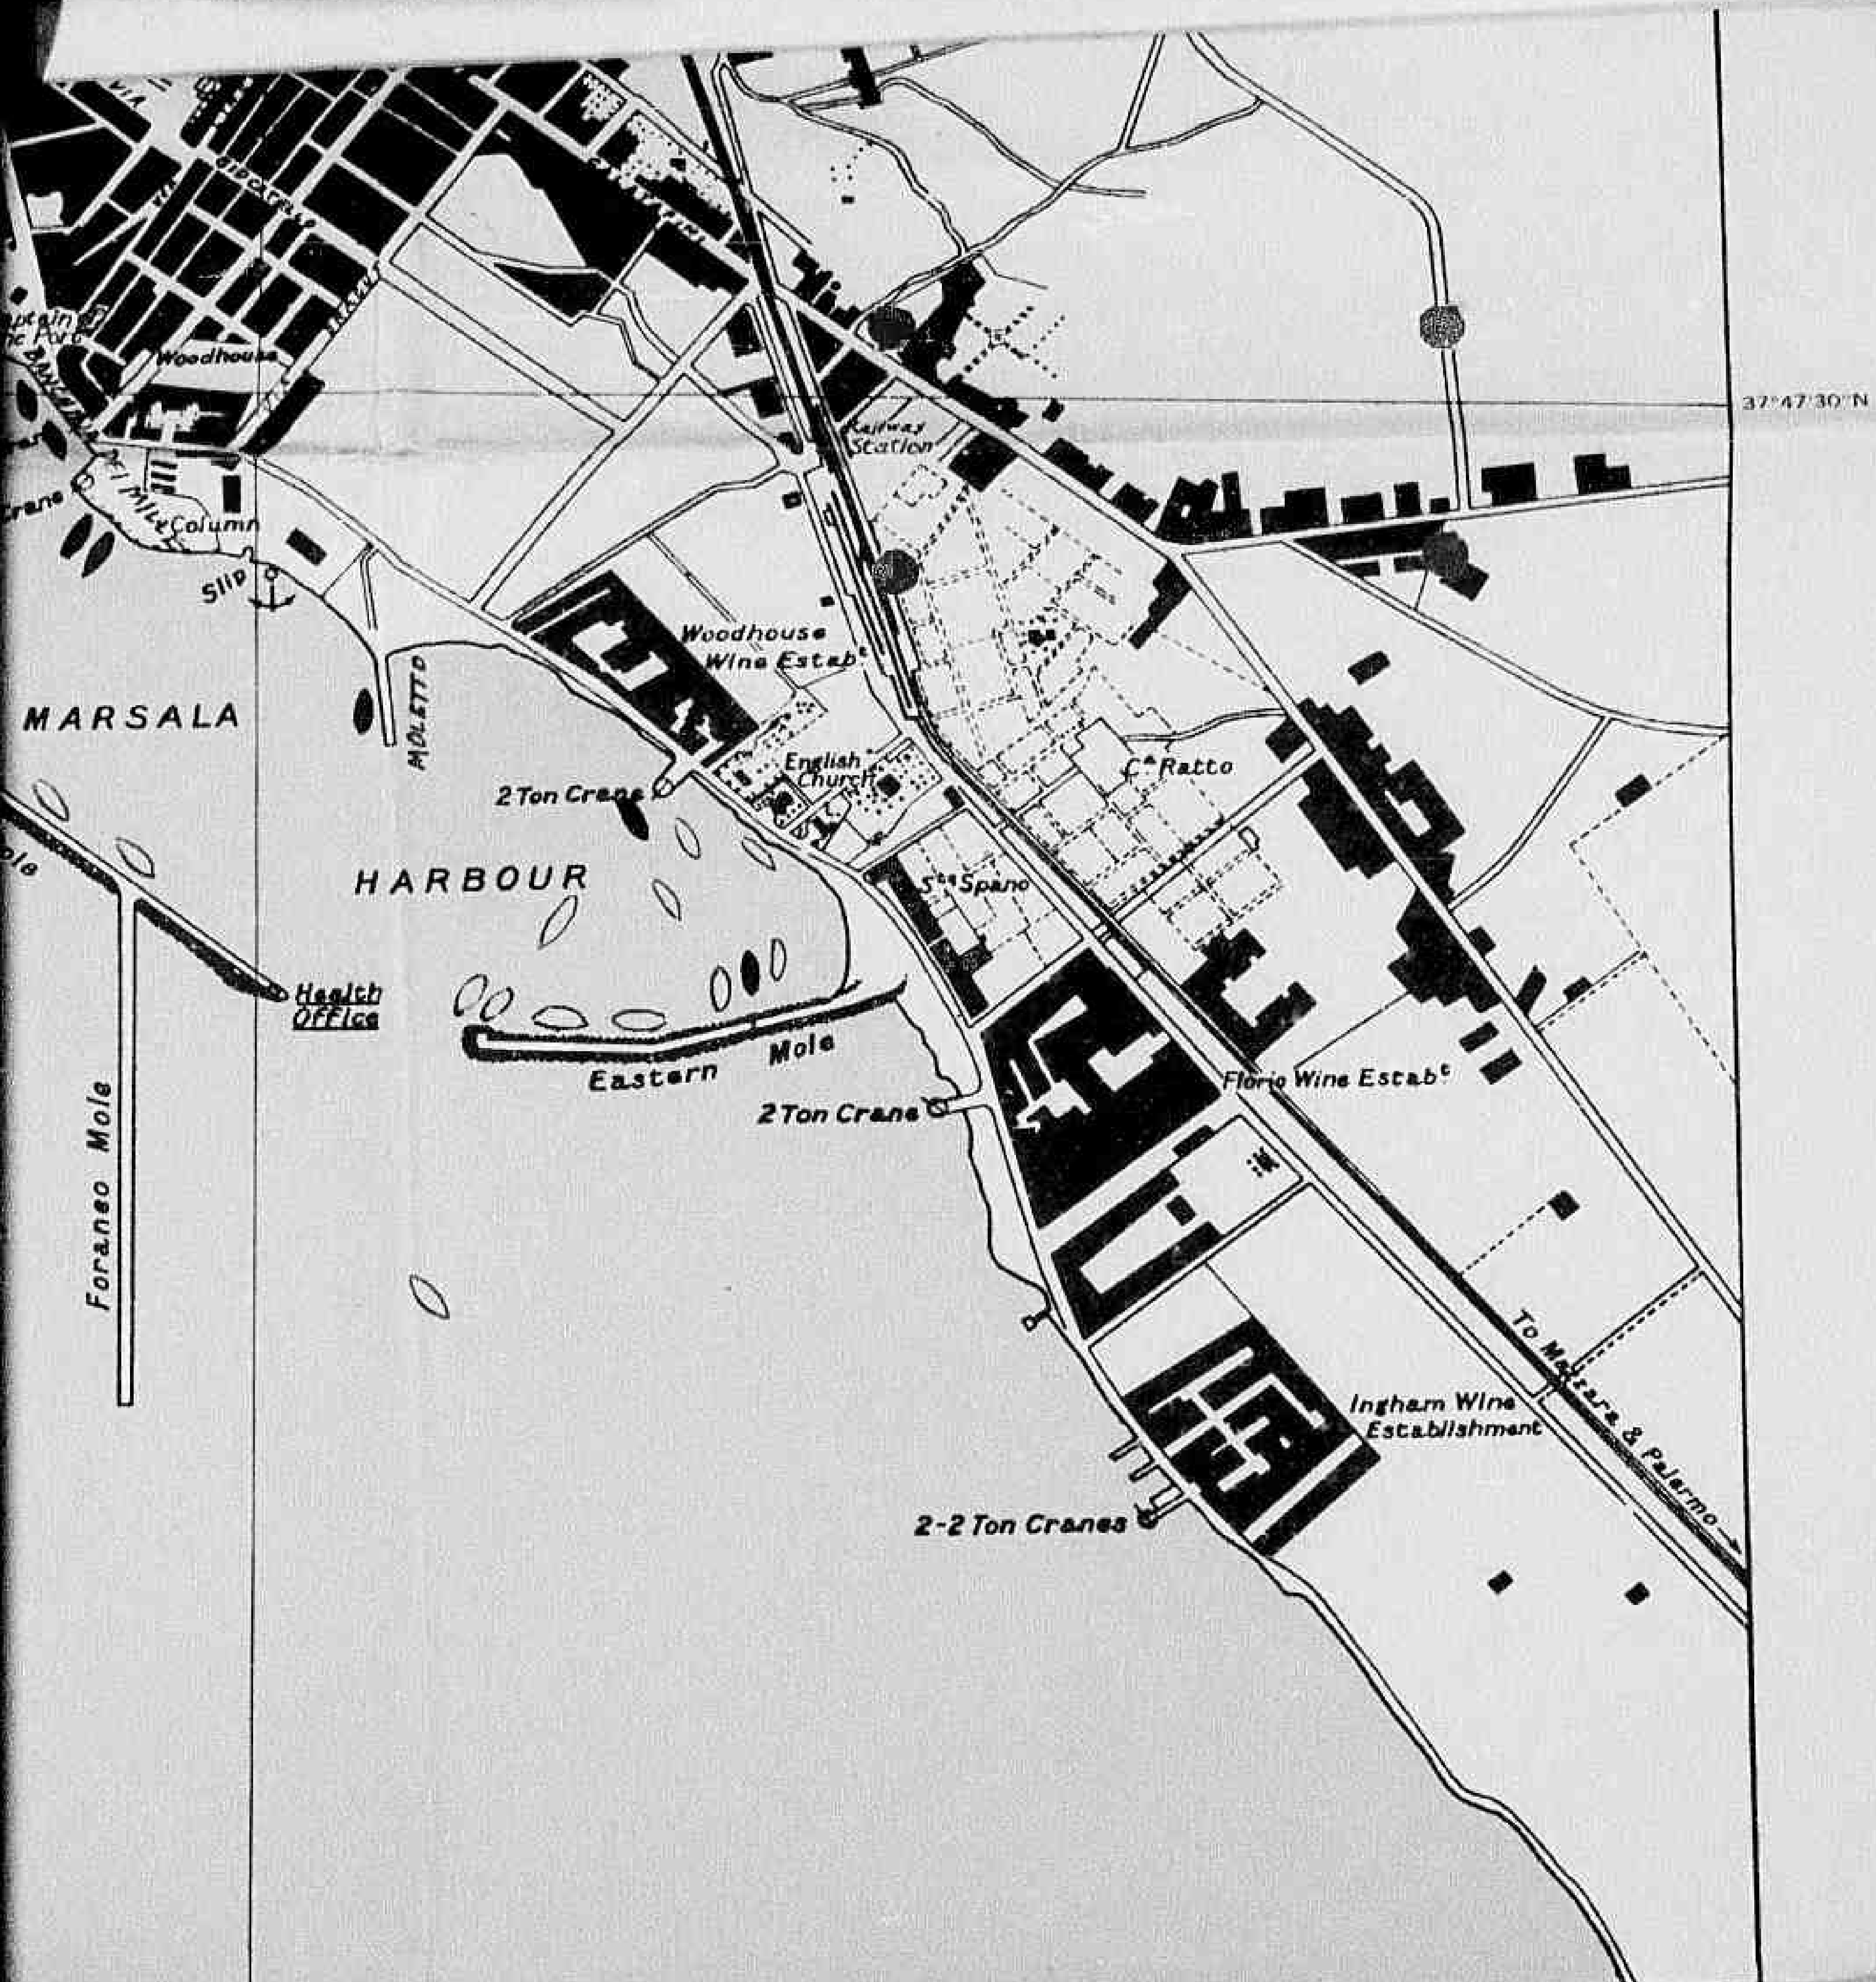
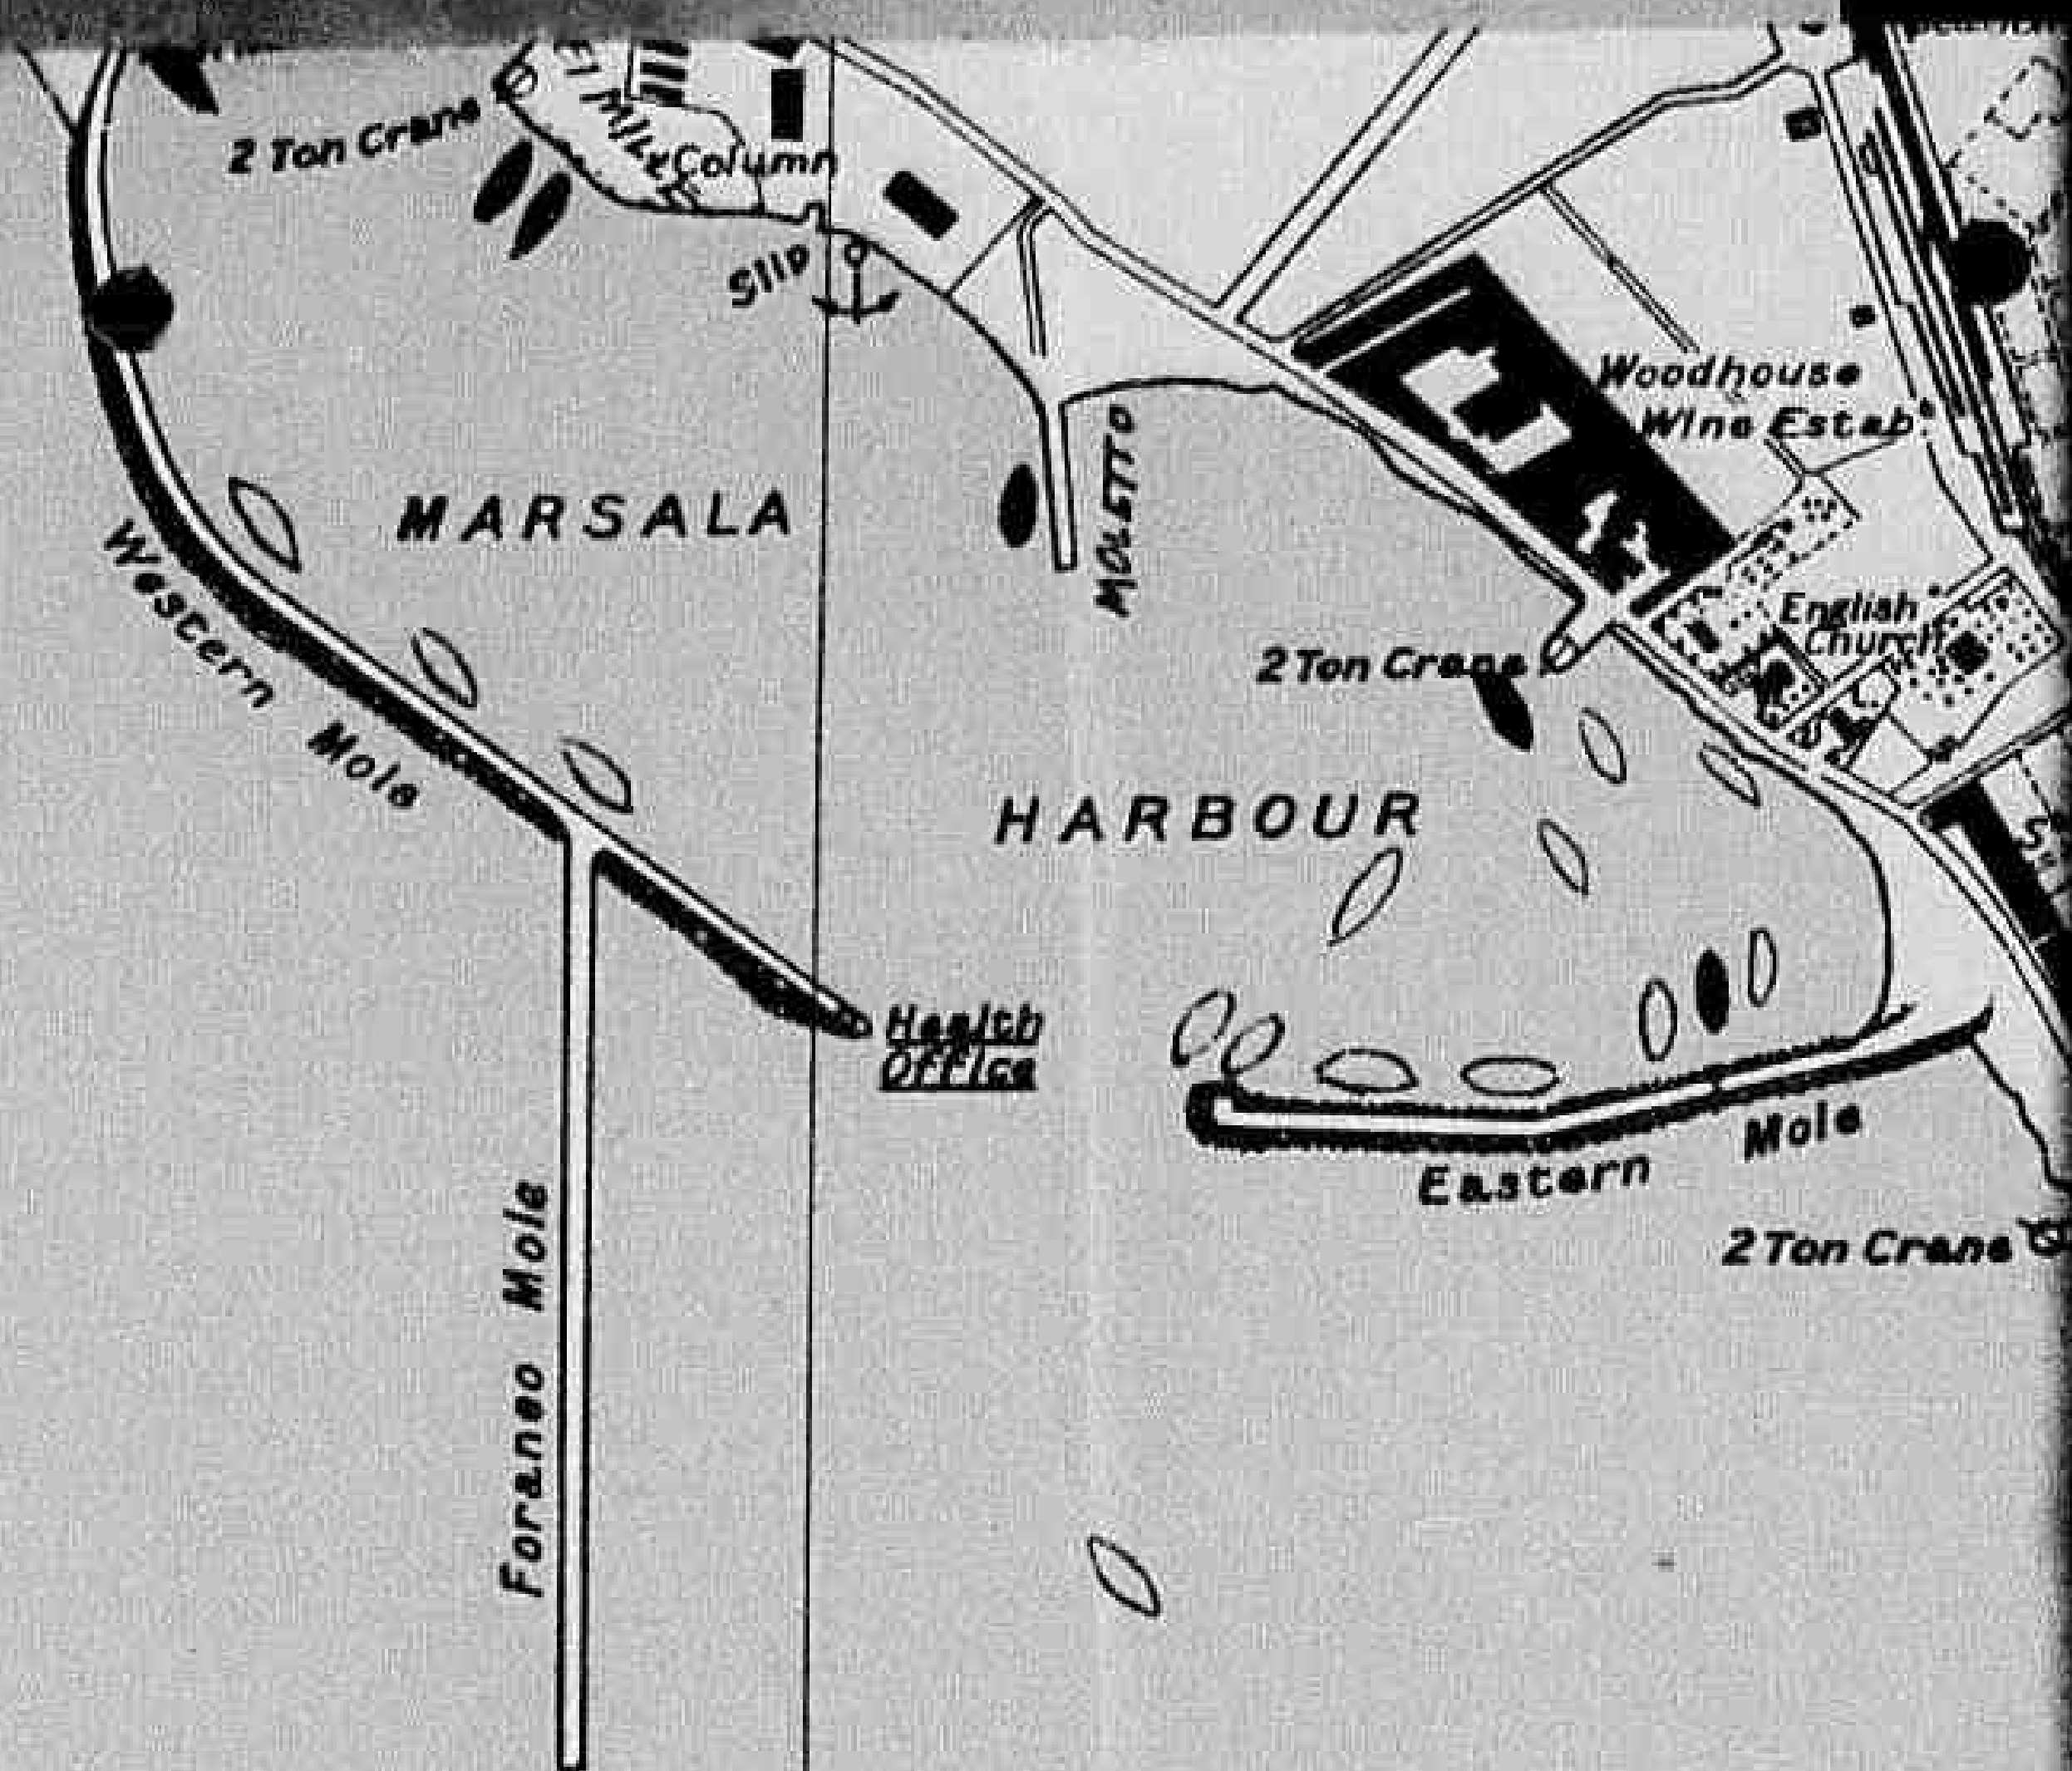
- Vessels raised
- Vessels sunk

Eighteen vessels, including one large dredger were sunk in the harbour during the invasion, of which six have been raised. Salvage work is now proceeding on the dredger and other vessels.

The southerly section of the harbour between Moletto and Molo Levante is littered with 10 sunken vessels, rendering this area too dangerous for use.

1. Repair breakwater (Foraneo Molo)
2. Raise sunken vessels in harbour.
