Sicilian Ports

EXTRACT  
FROM  
TRANSPORTATION NEWS LETTER  
OF  
16 October, 1942

PALERMO  
REPORT, N. D. S.  
1920-1921

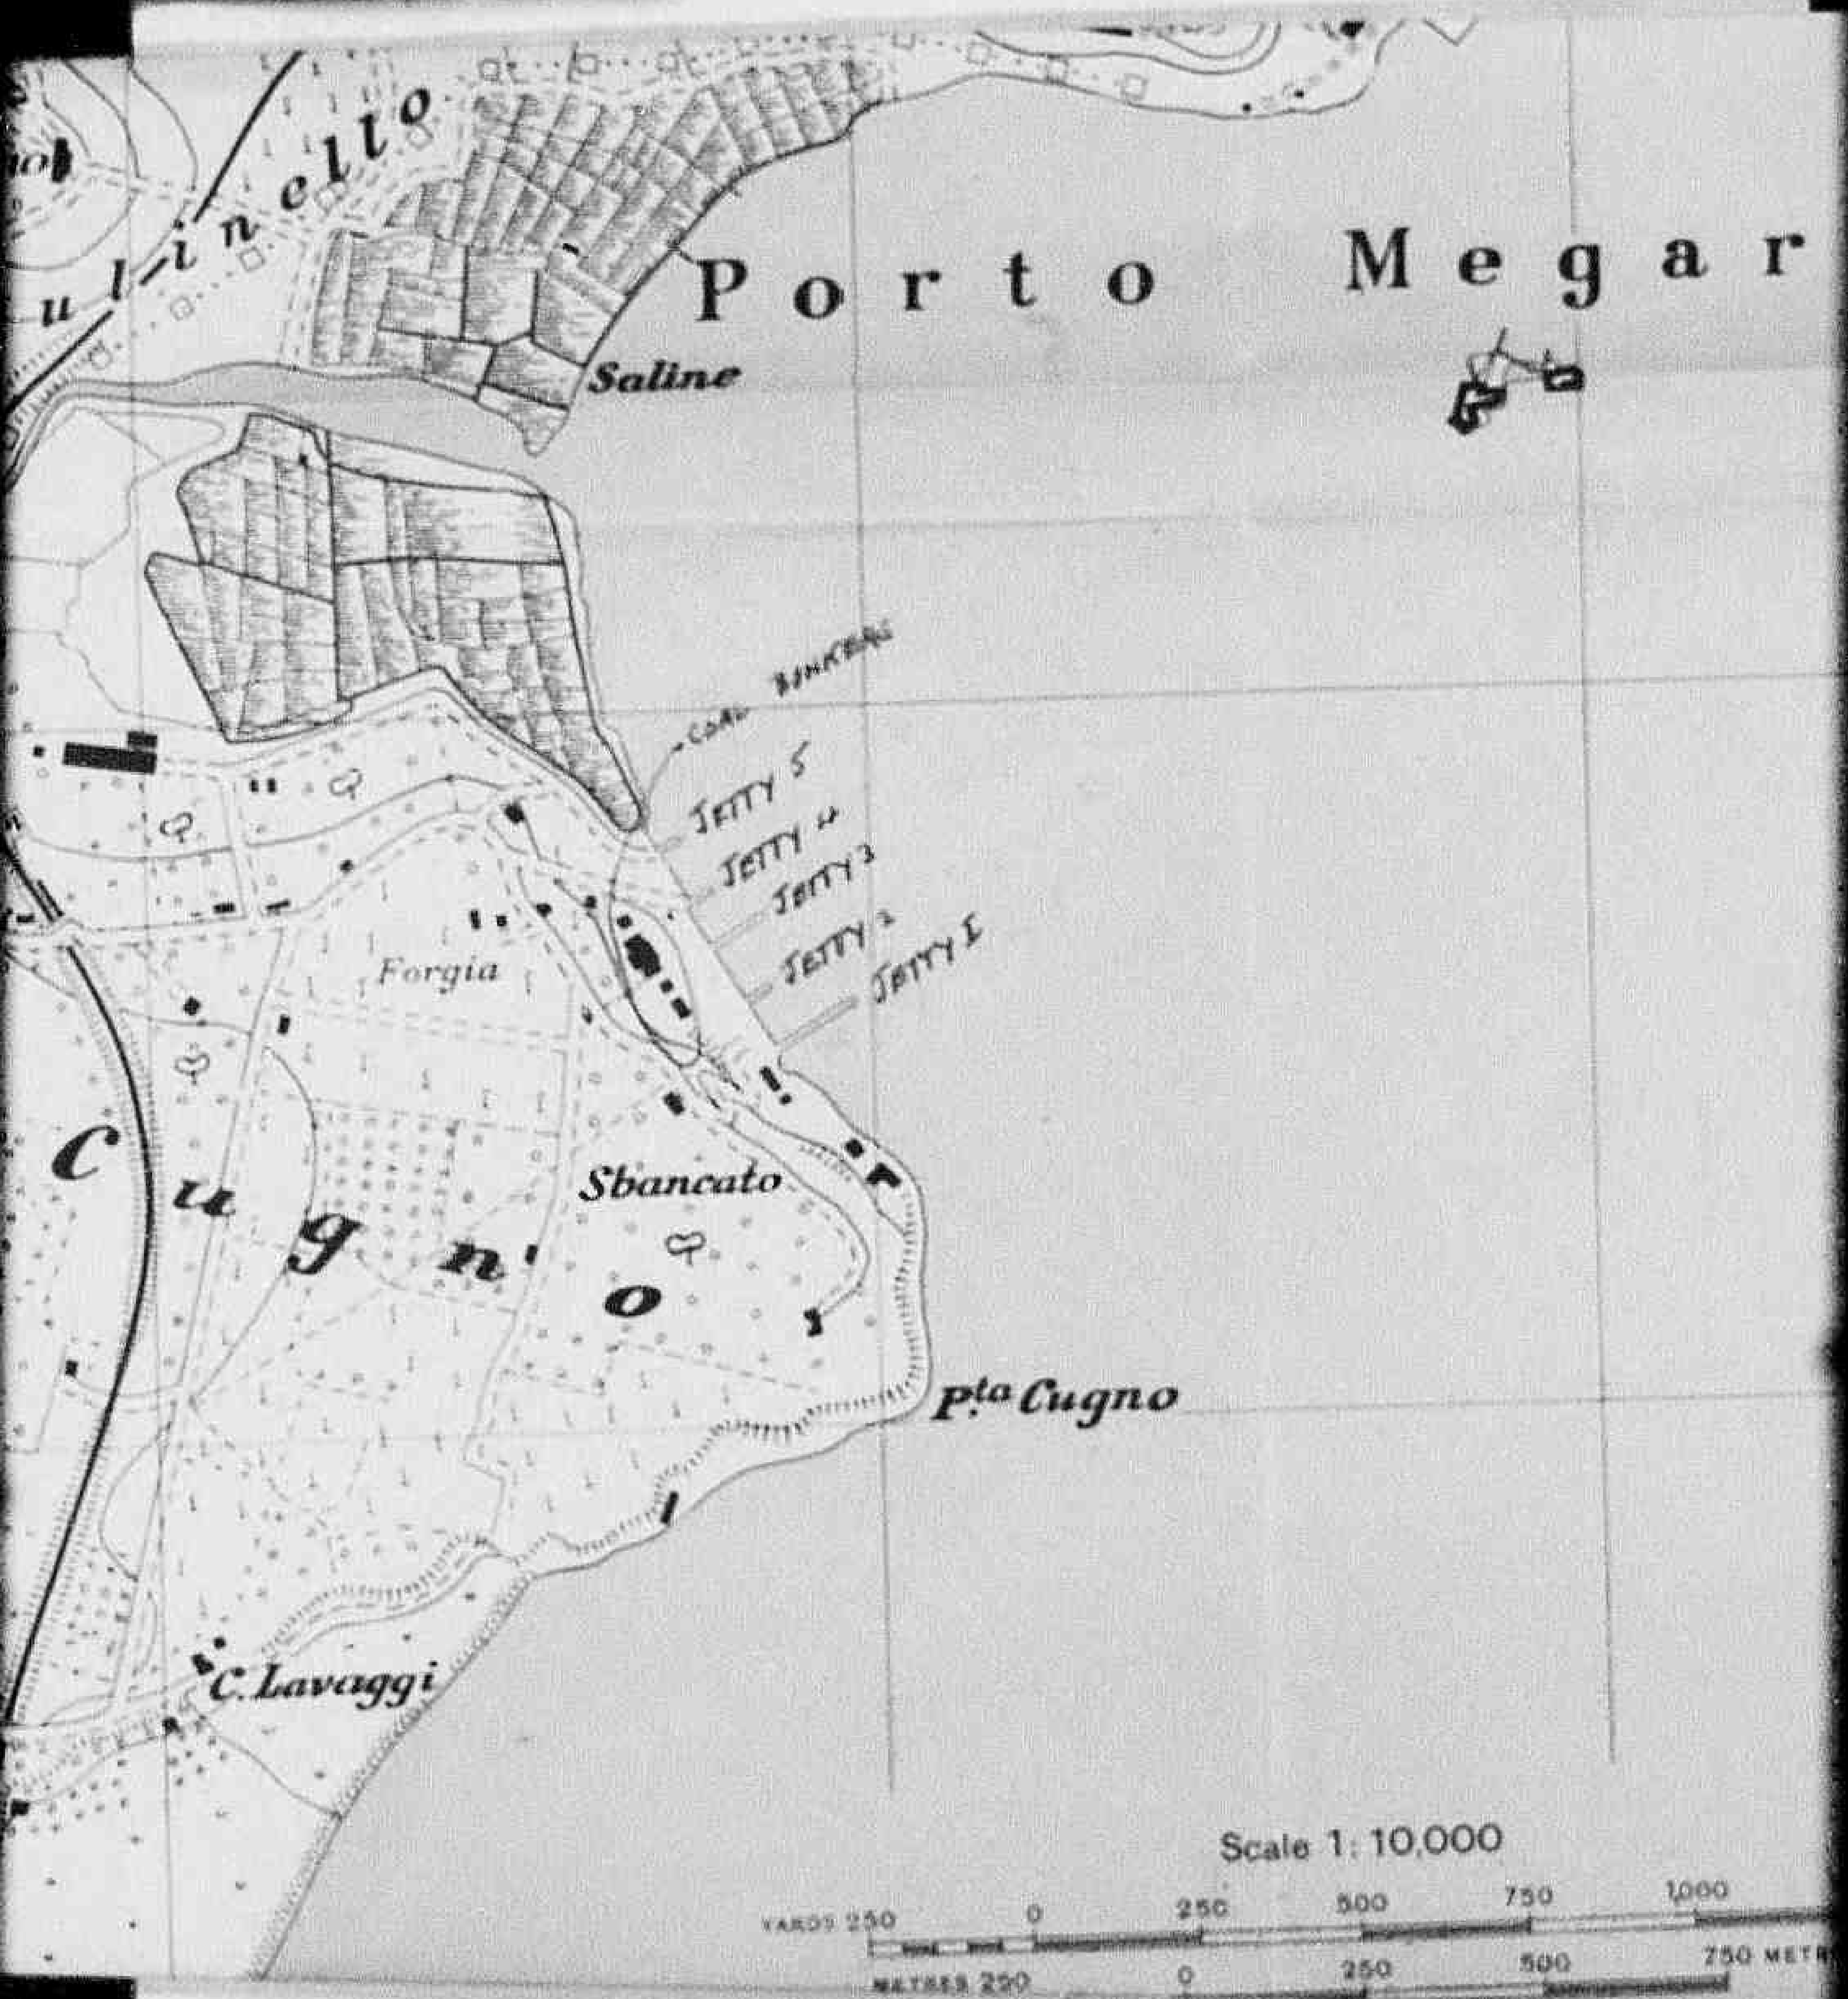
REFER TO THIS MAP AS  
1:10,000 TOWN PLANS AUGUSTA

# AUGUSTA

Revised by S12 Fd, Survey Corp., R. E. Lutz, 1943, by enlargement  
of 1:25,000 Italy sheets. Revised from Air Photographs dated 1943

To substitute wharfage presently damaged beyond use, there is a possibility that improvisations may be created in the vicinity of "Unit 1" (see map for location). Contingent on good weather, six vessels of unlimited draft could be secured stern to, and loaded or discharged by lighter.

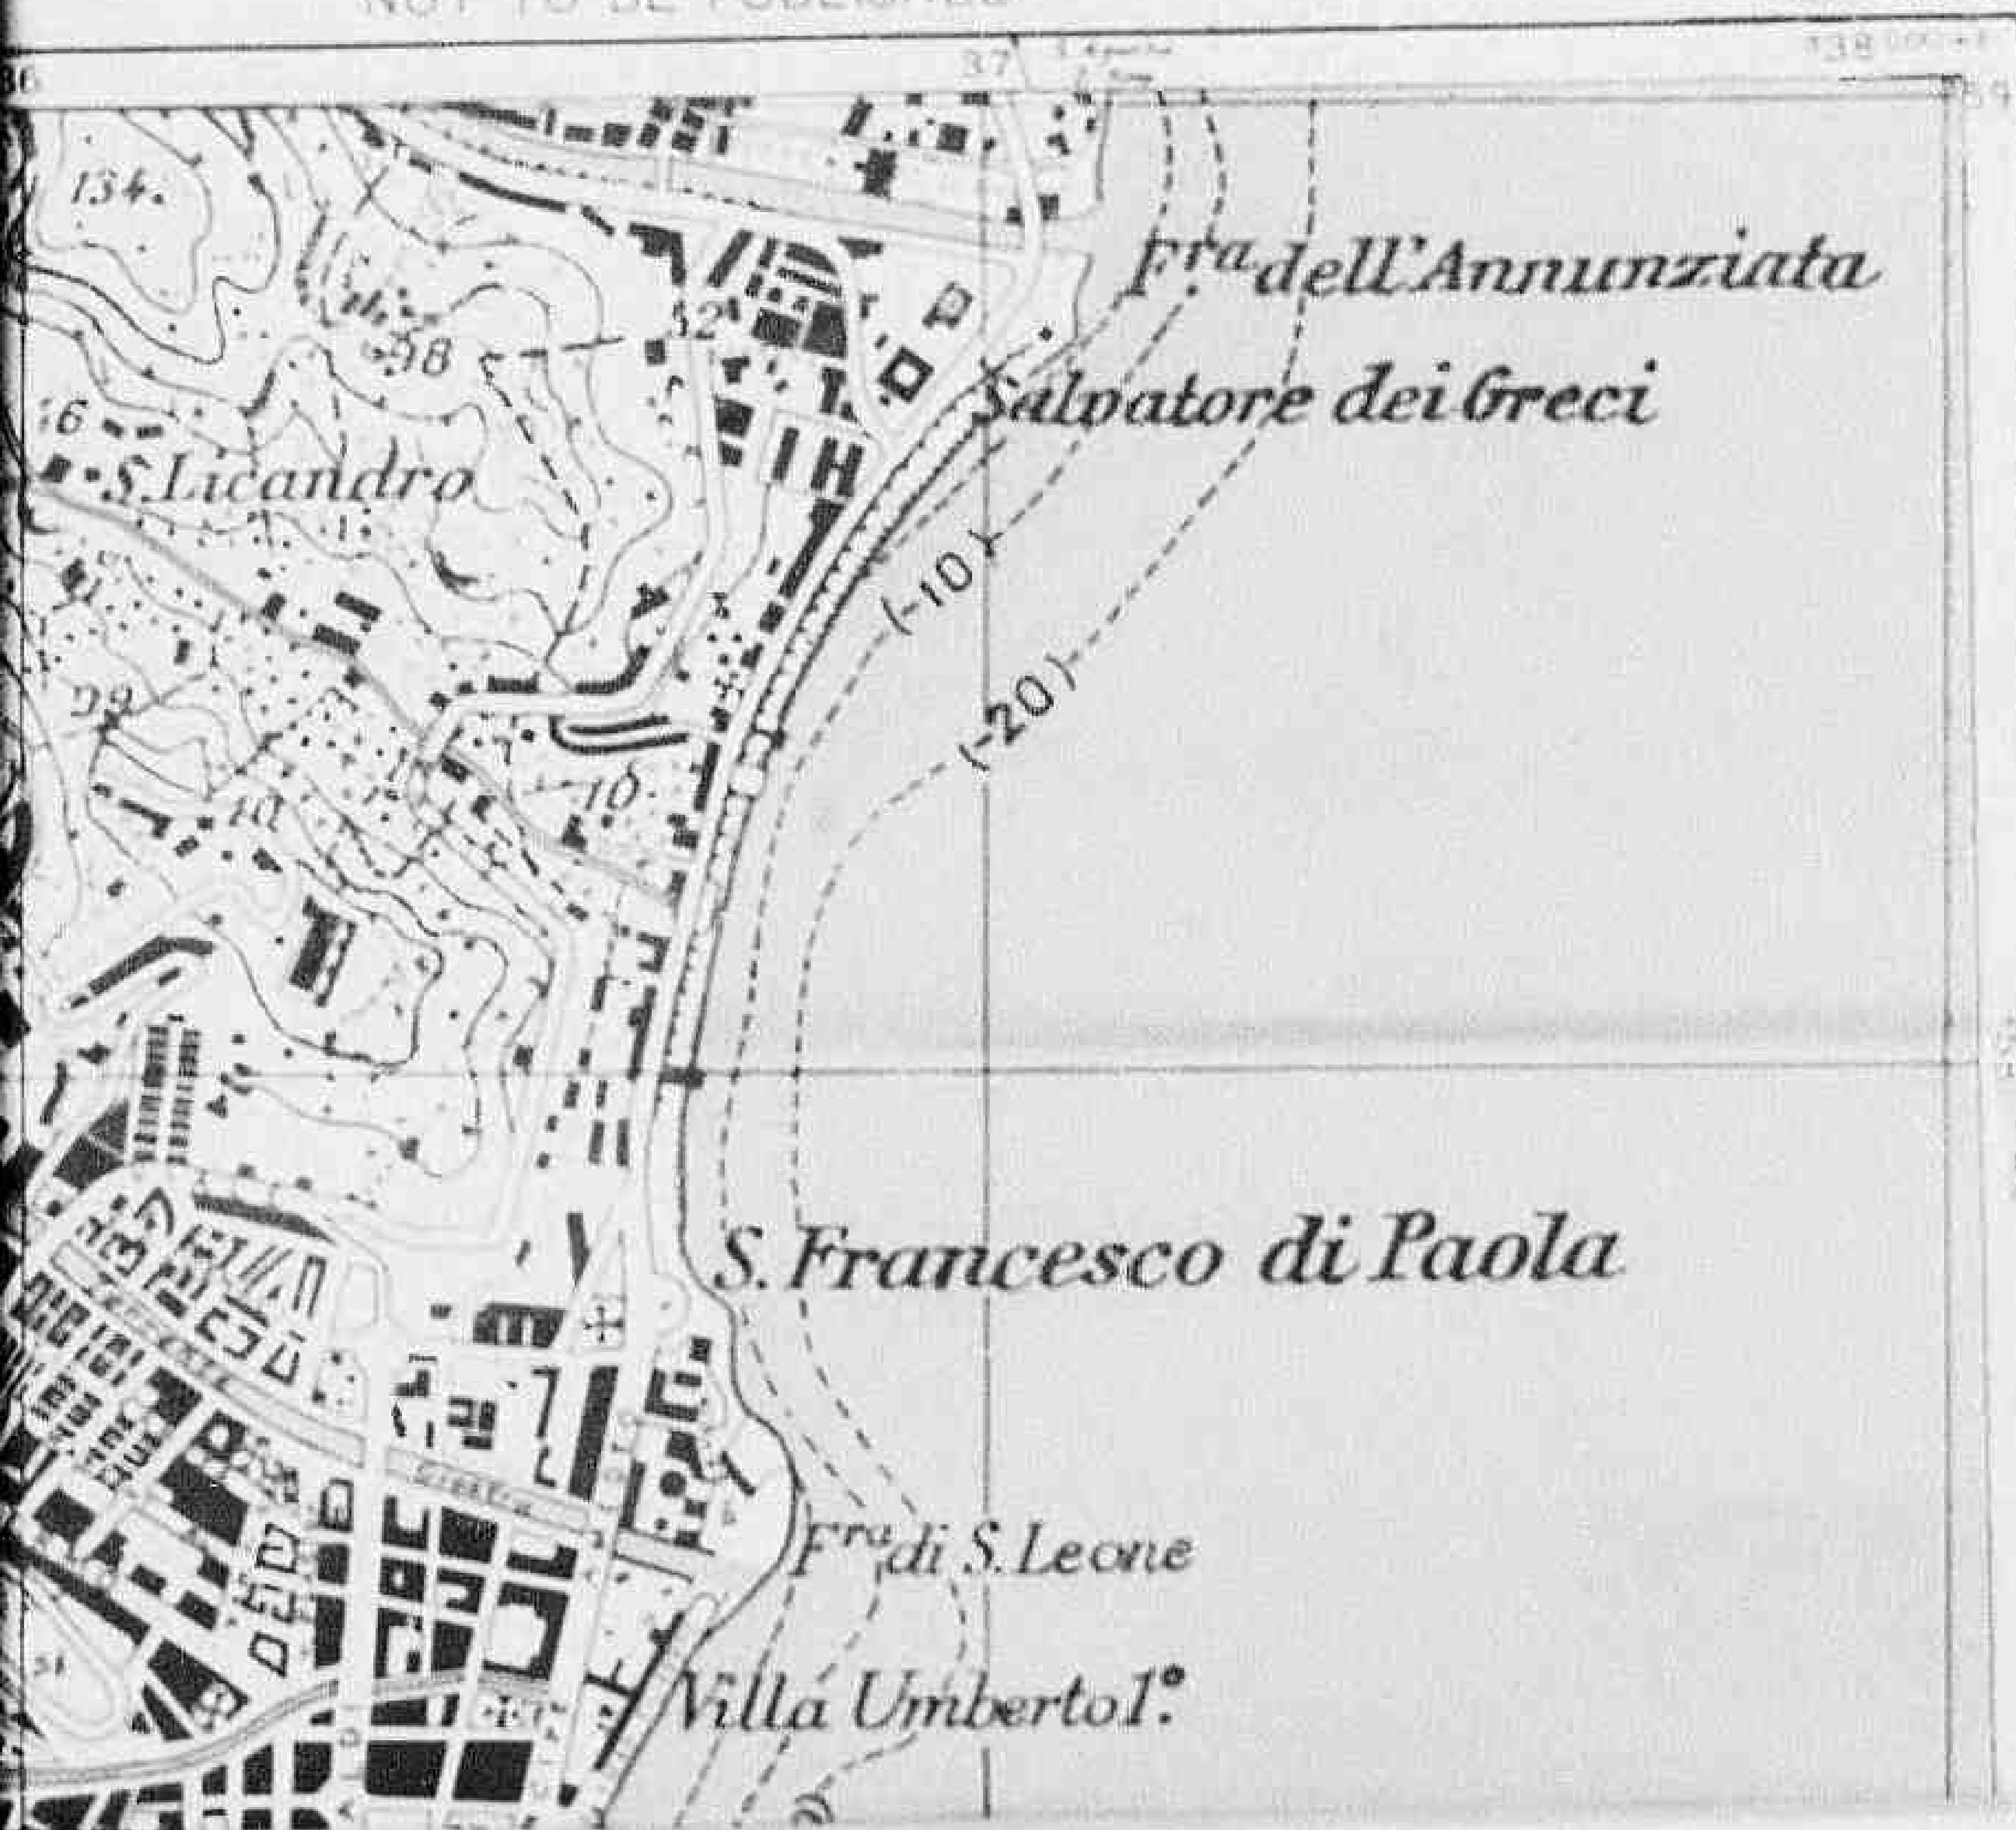
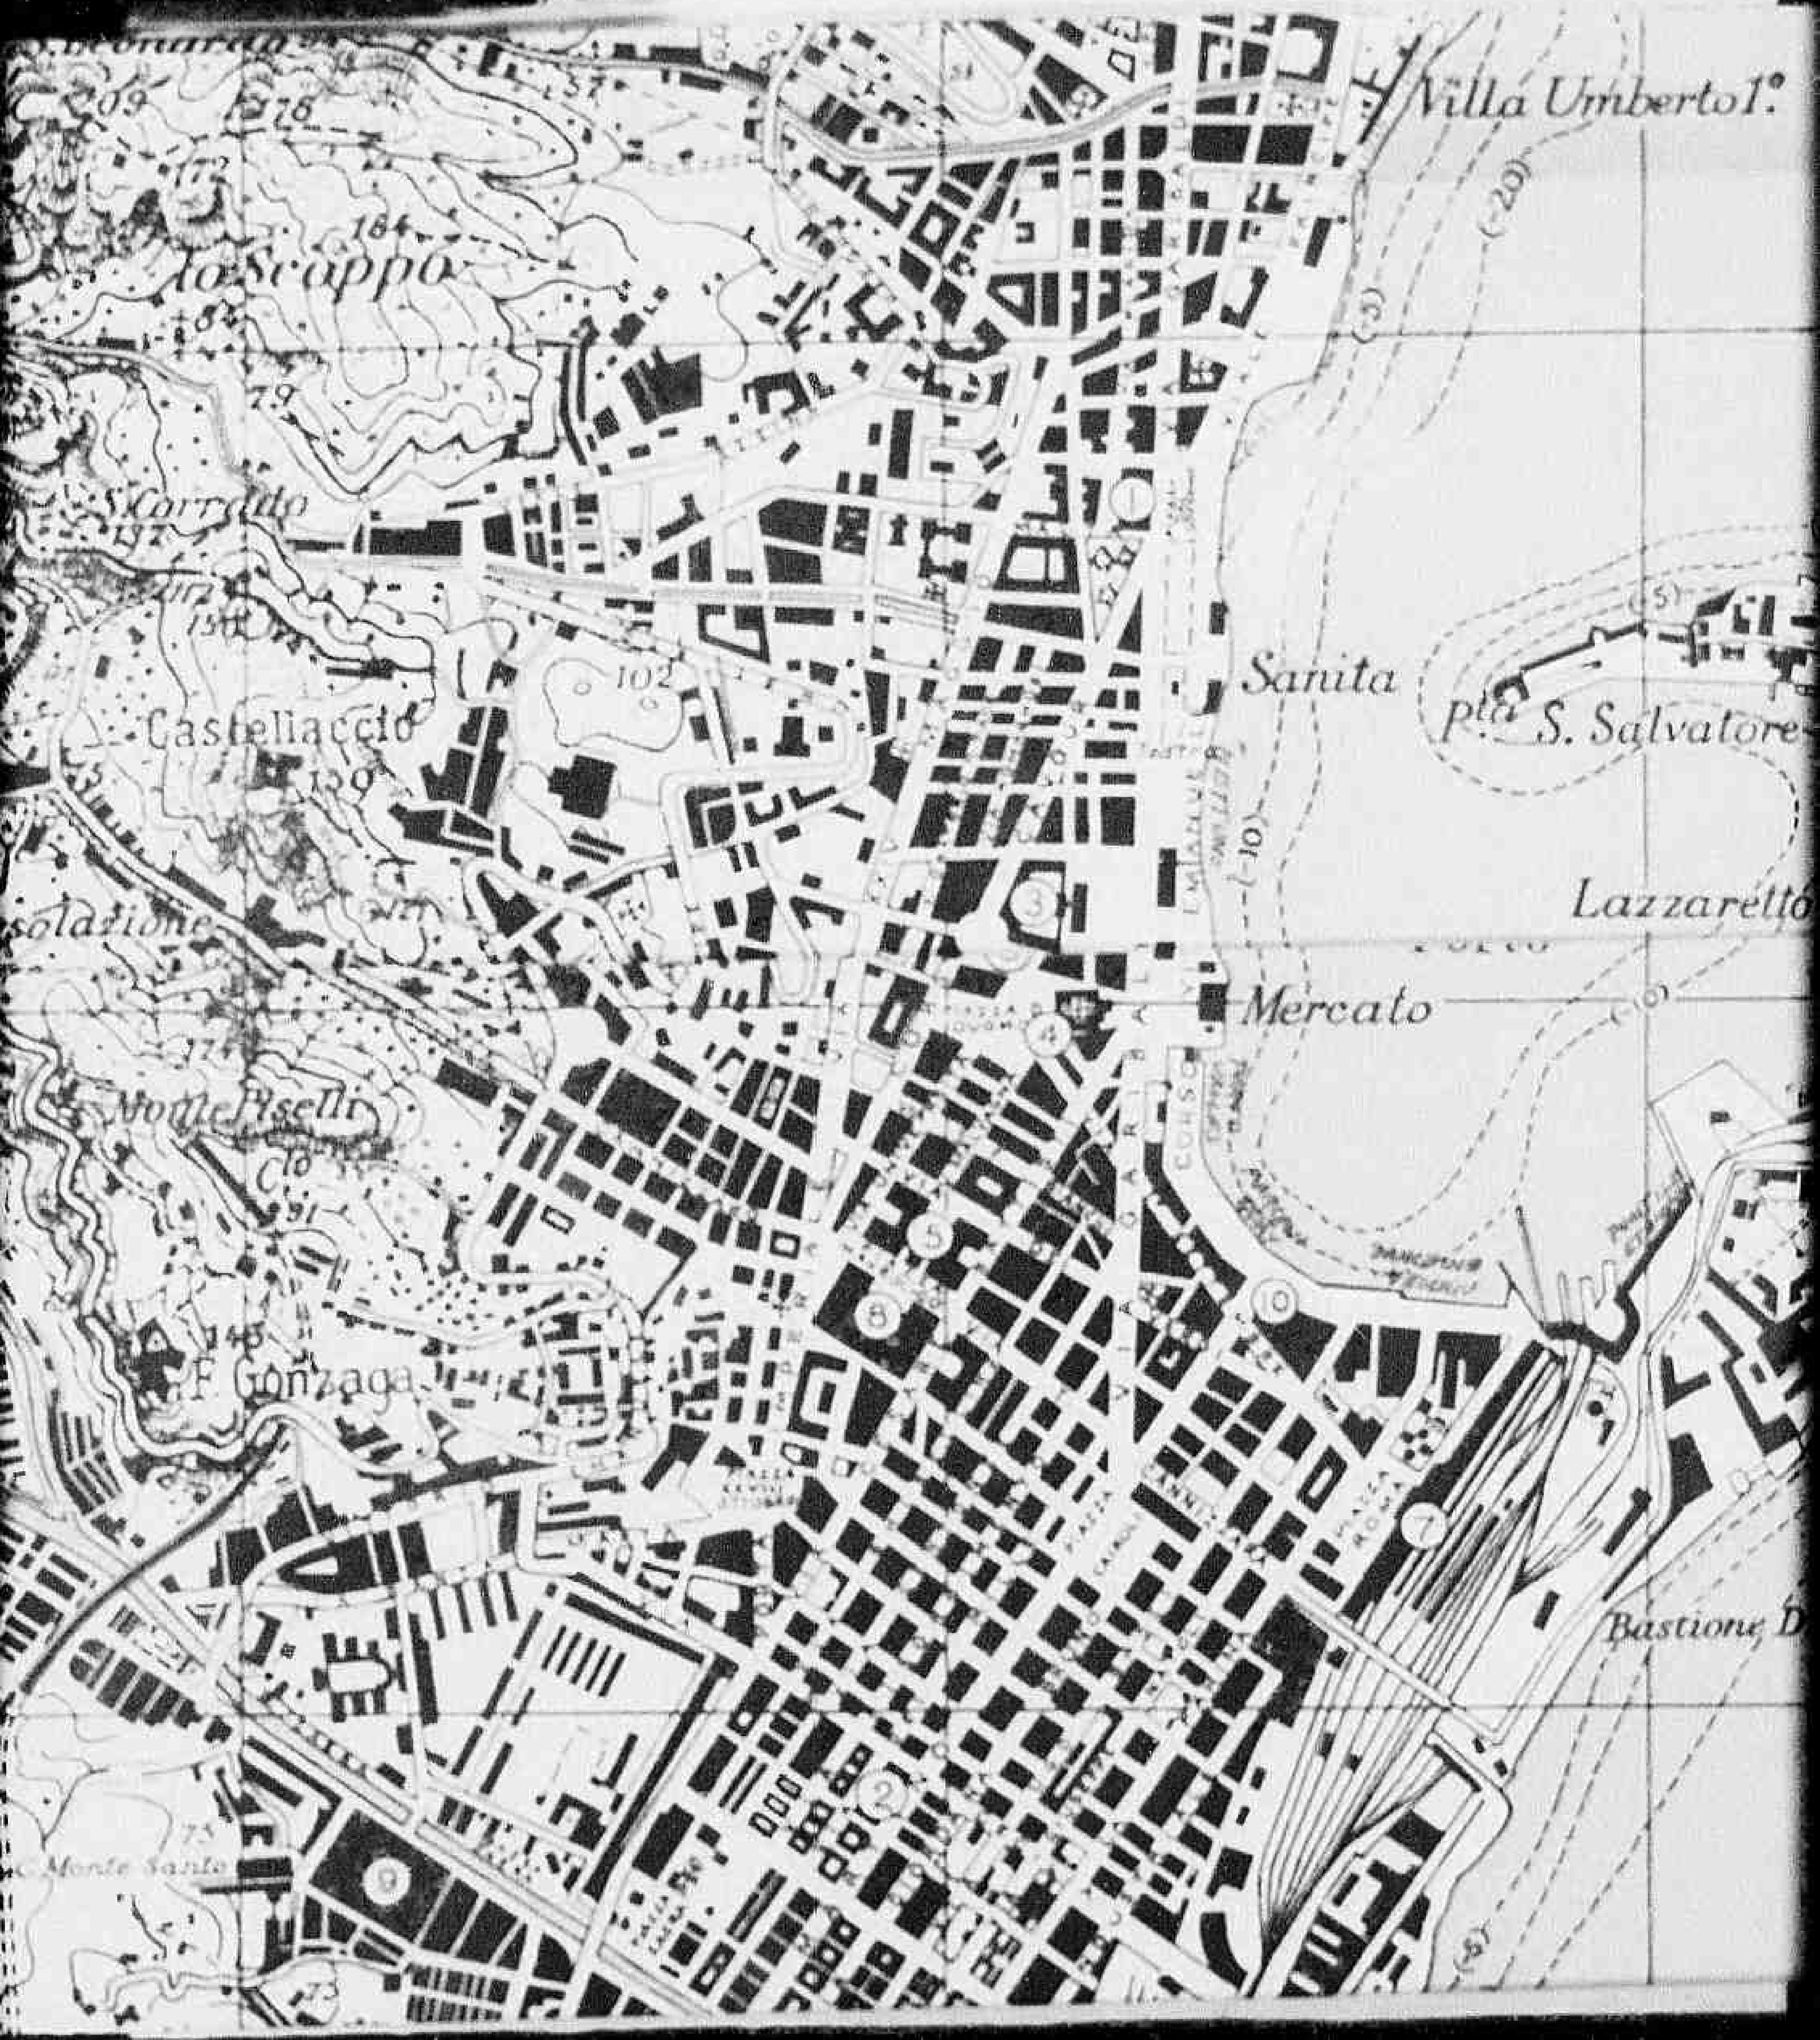
REFER TO THIS MAP AS  
1:10,000 TOWN PLAN, MESSINA

Reproduced by S12 Ft. Survey Corp., R. E., June, 1943, by enlargement of 1:25,000 Italy sheets. Revised from Air Photographs dated 1942

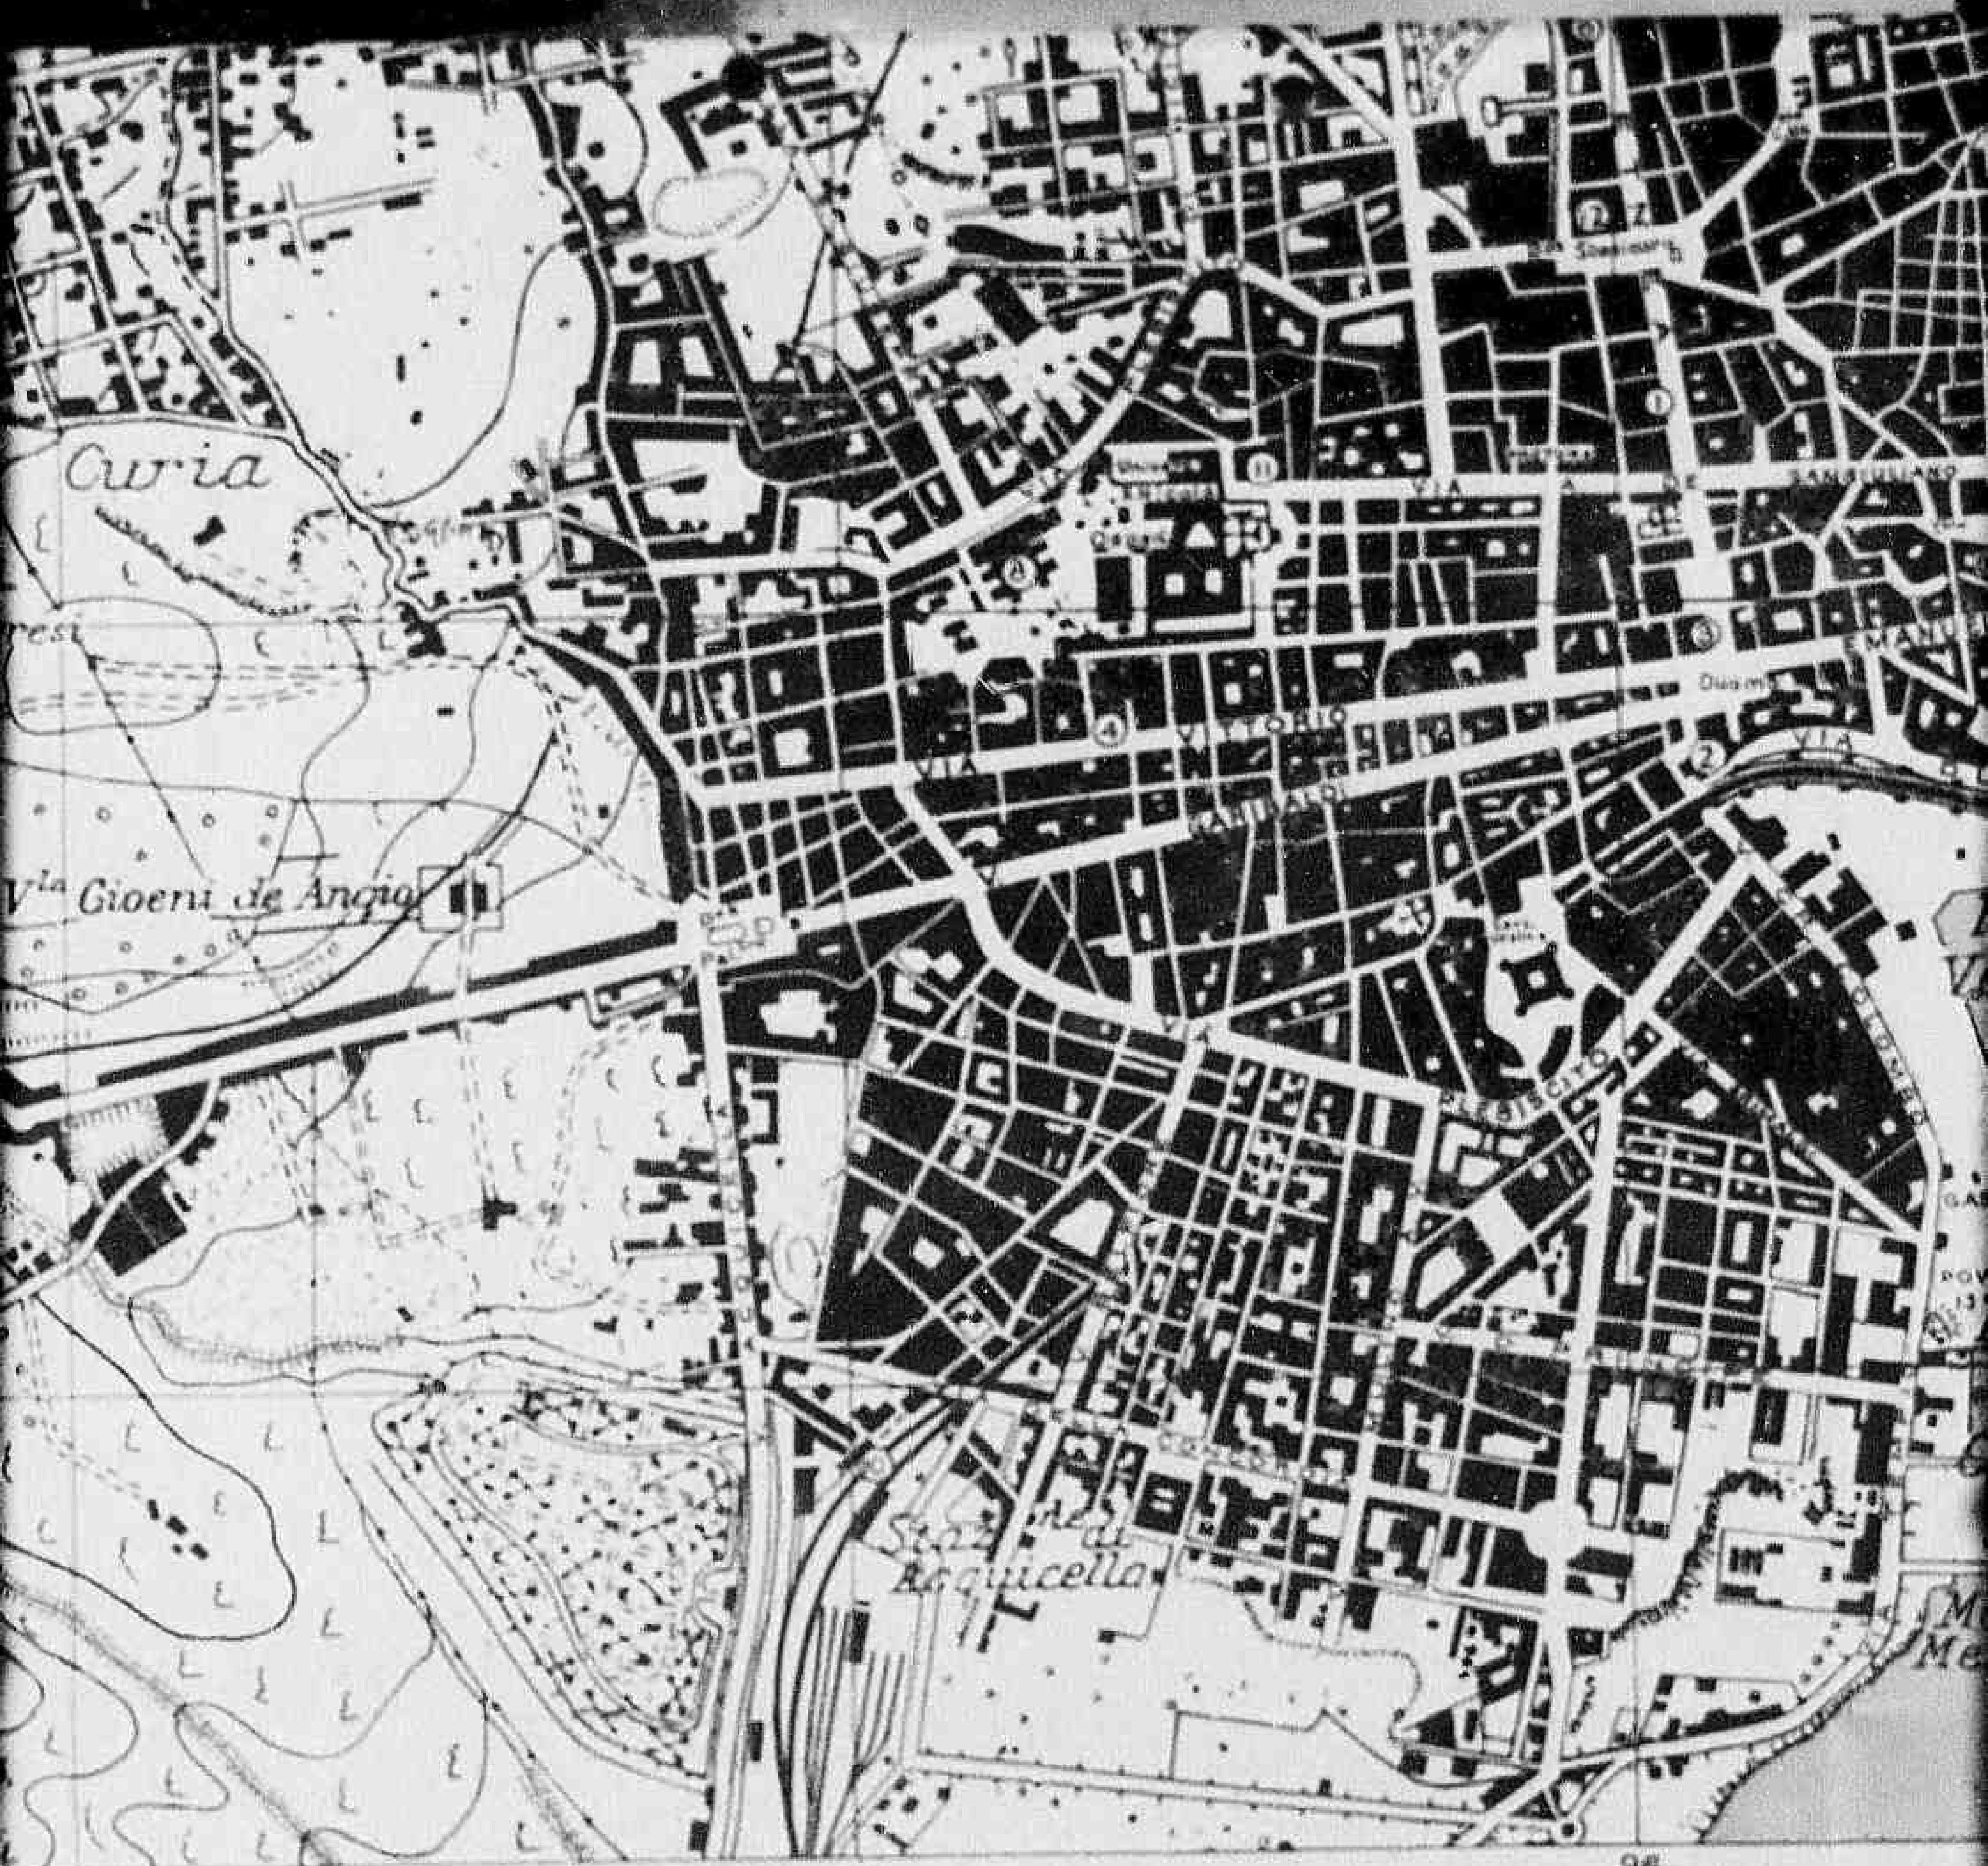
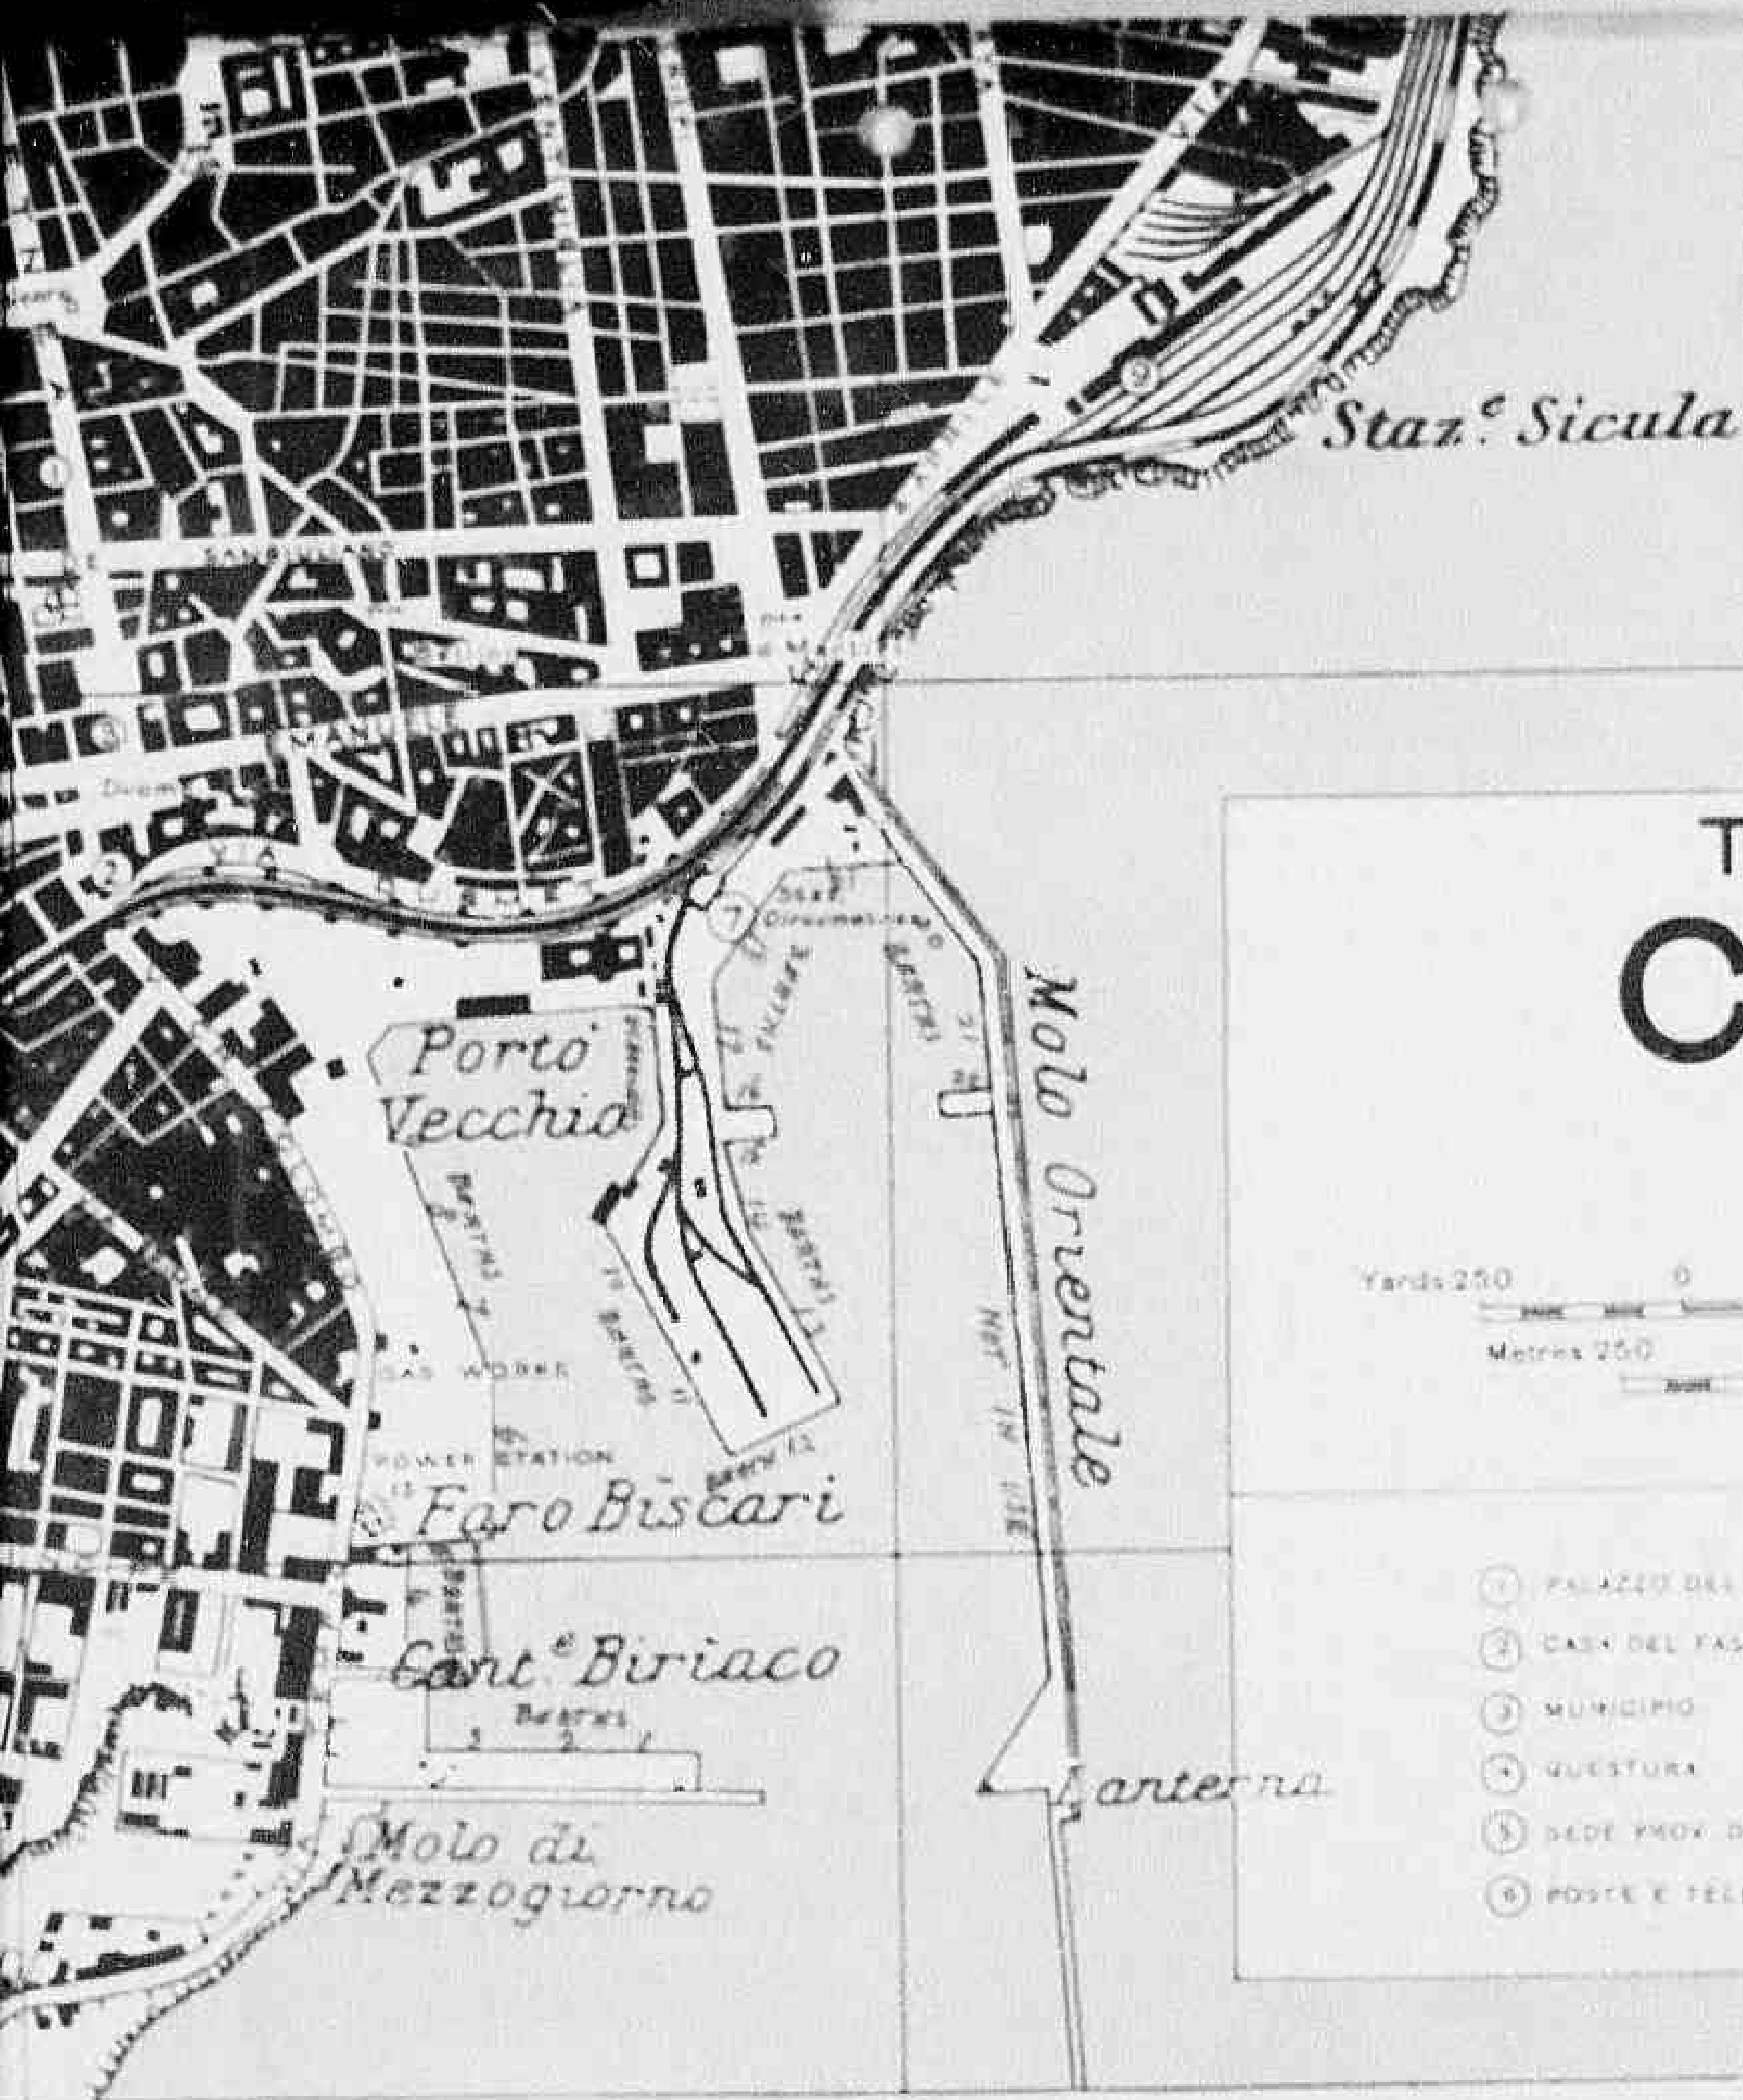
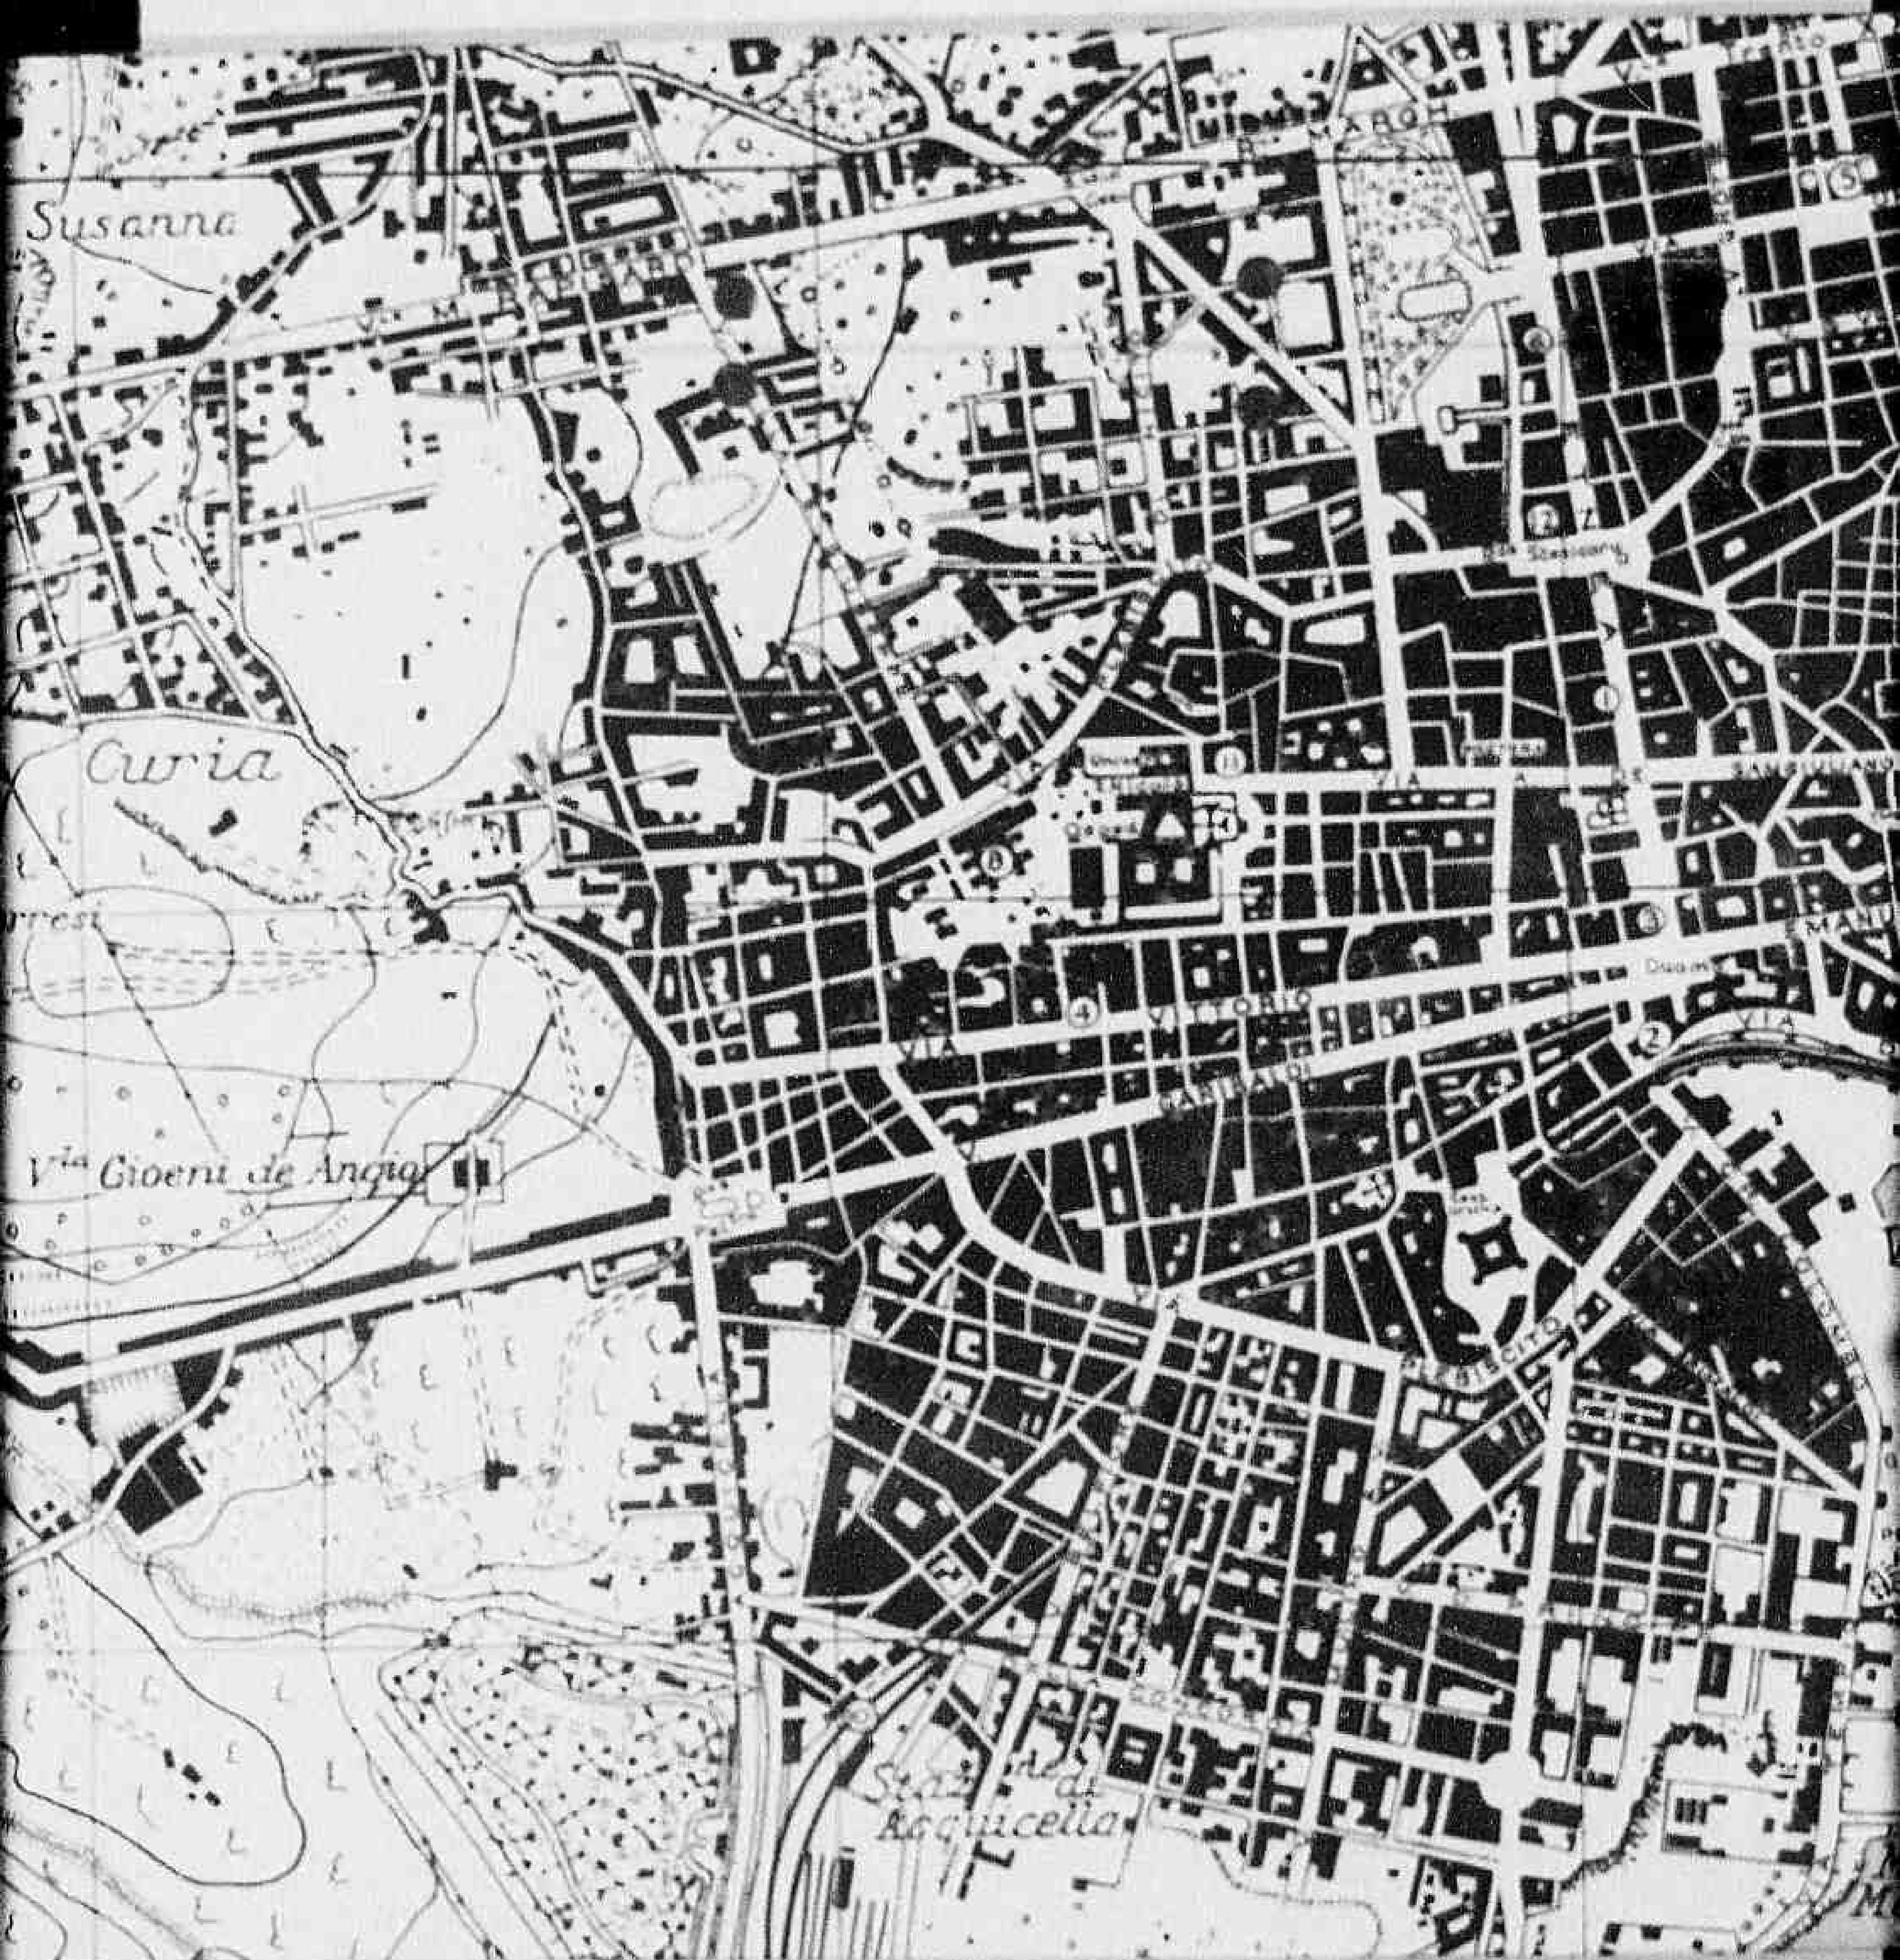
# TOWN PLAN OF CATANIA

GS.GS No. 4379

Scale 1:10,000

- ⑦ STAZ. CIRCUMETNEA
- ⑧ OSPEDALE
- ⑨ STAZ. F.S.
- ⑩ STAZ. ACQUICELLA
- ⑪ OSPEDALE S. MARTA
- ✚ CHURCH
