Sicilian Ports

EXTRACT  
FROM  
TRANSPORTATION NEWS LETTER  
OF  
16 October, 1942

PALERMO  
REPORT, N. D. S.  
1920-1921

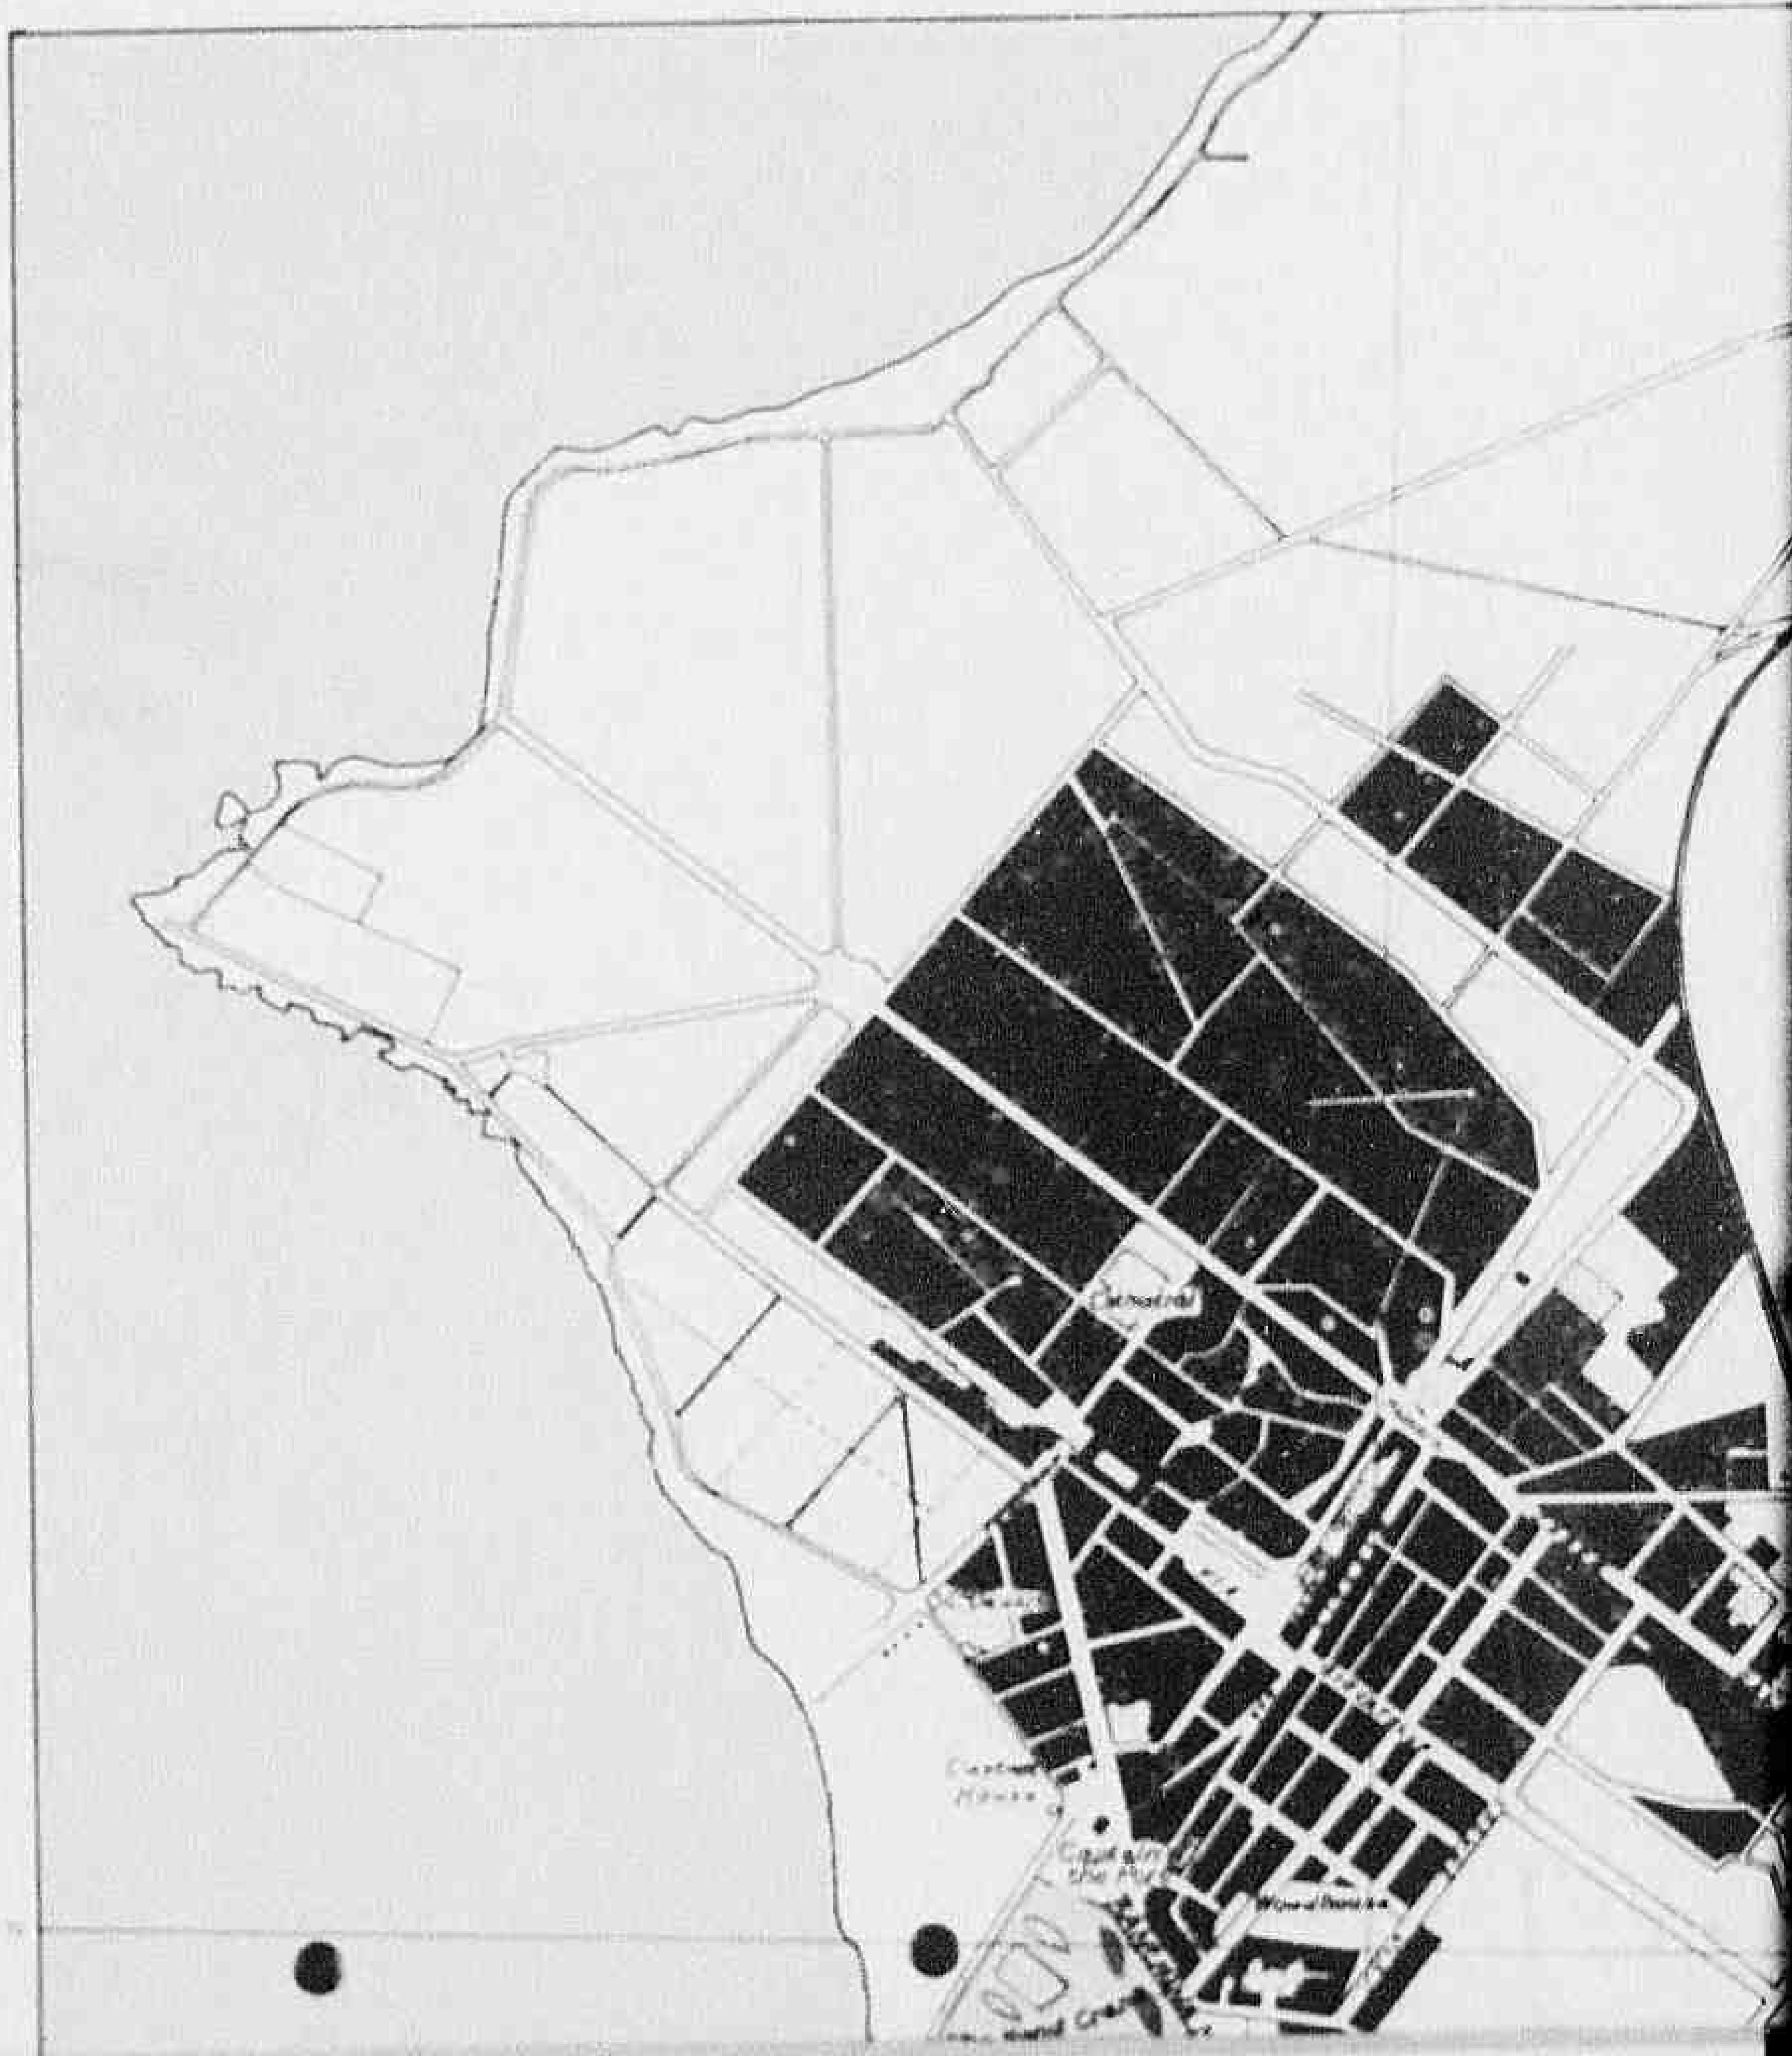
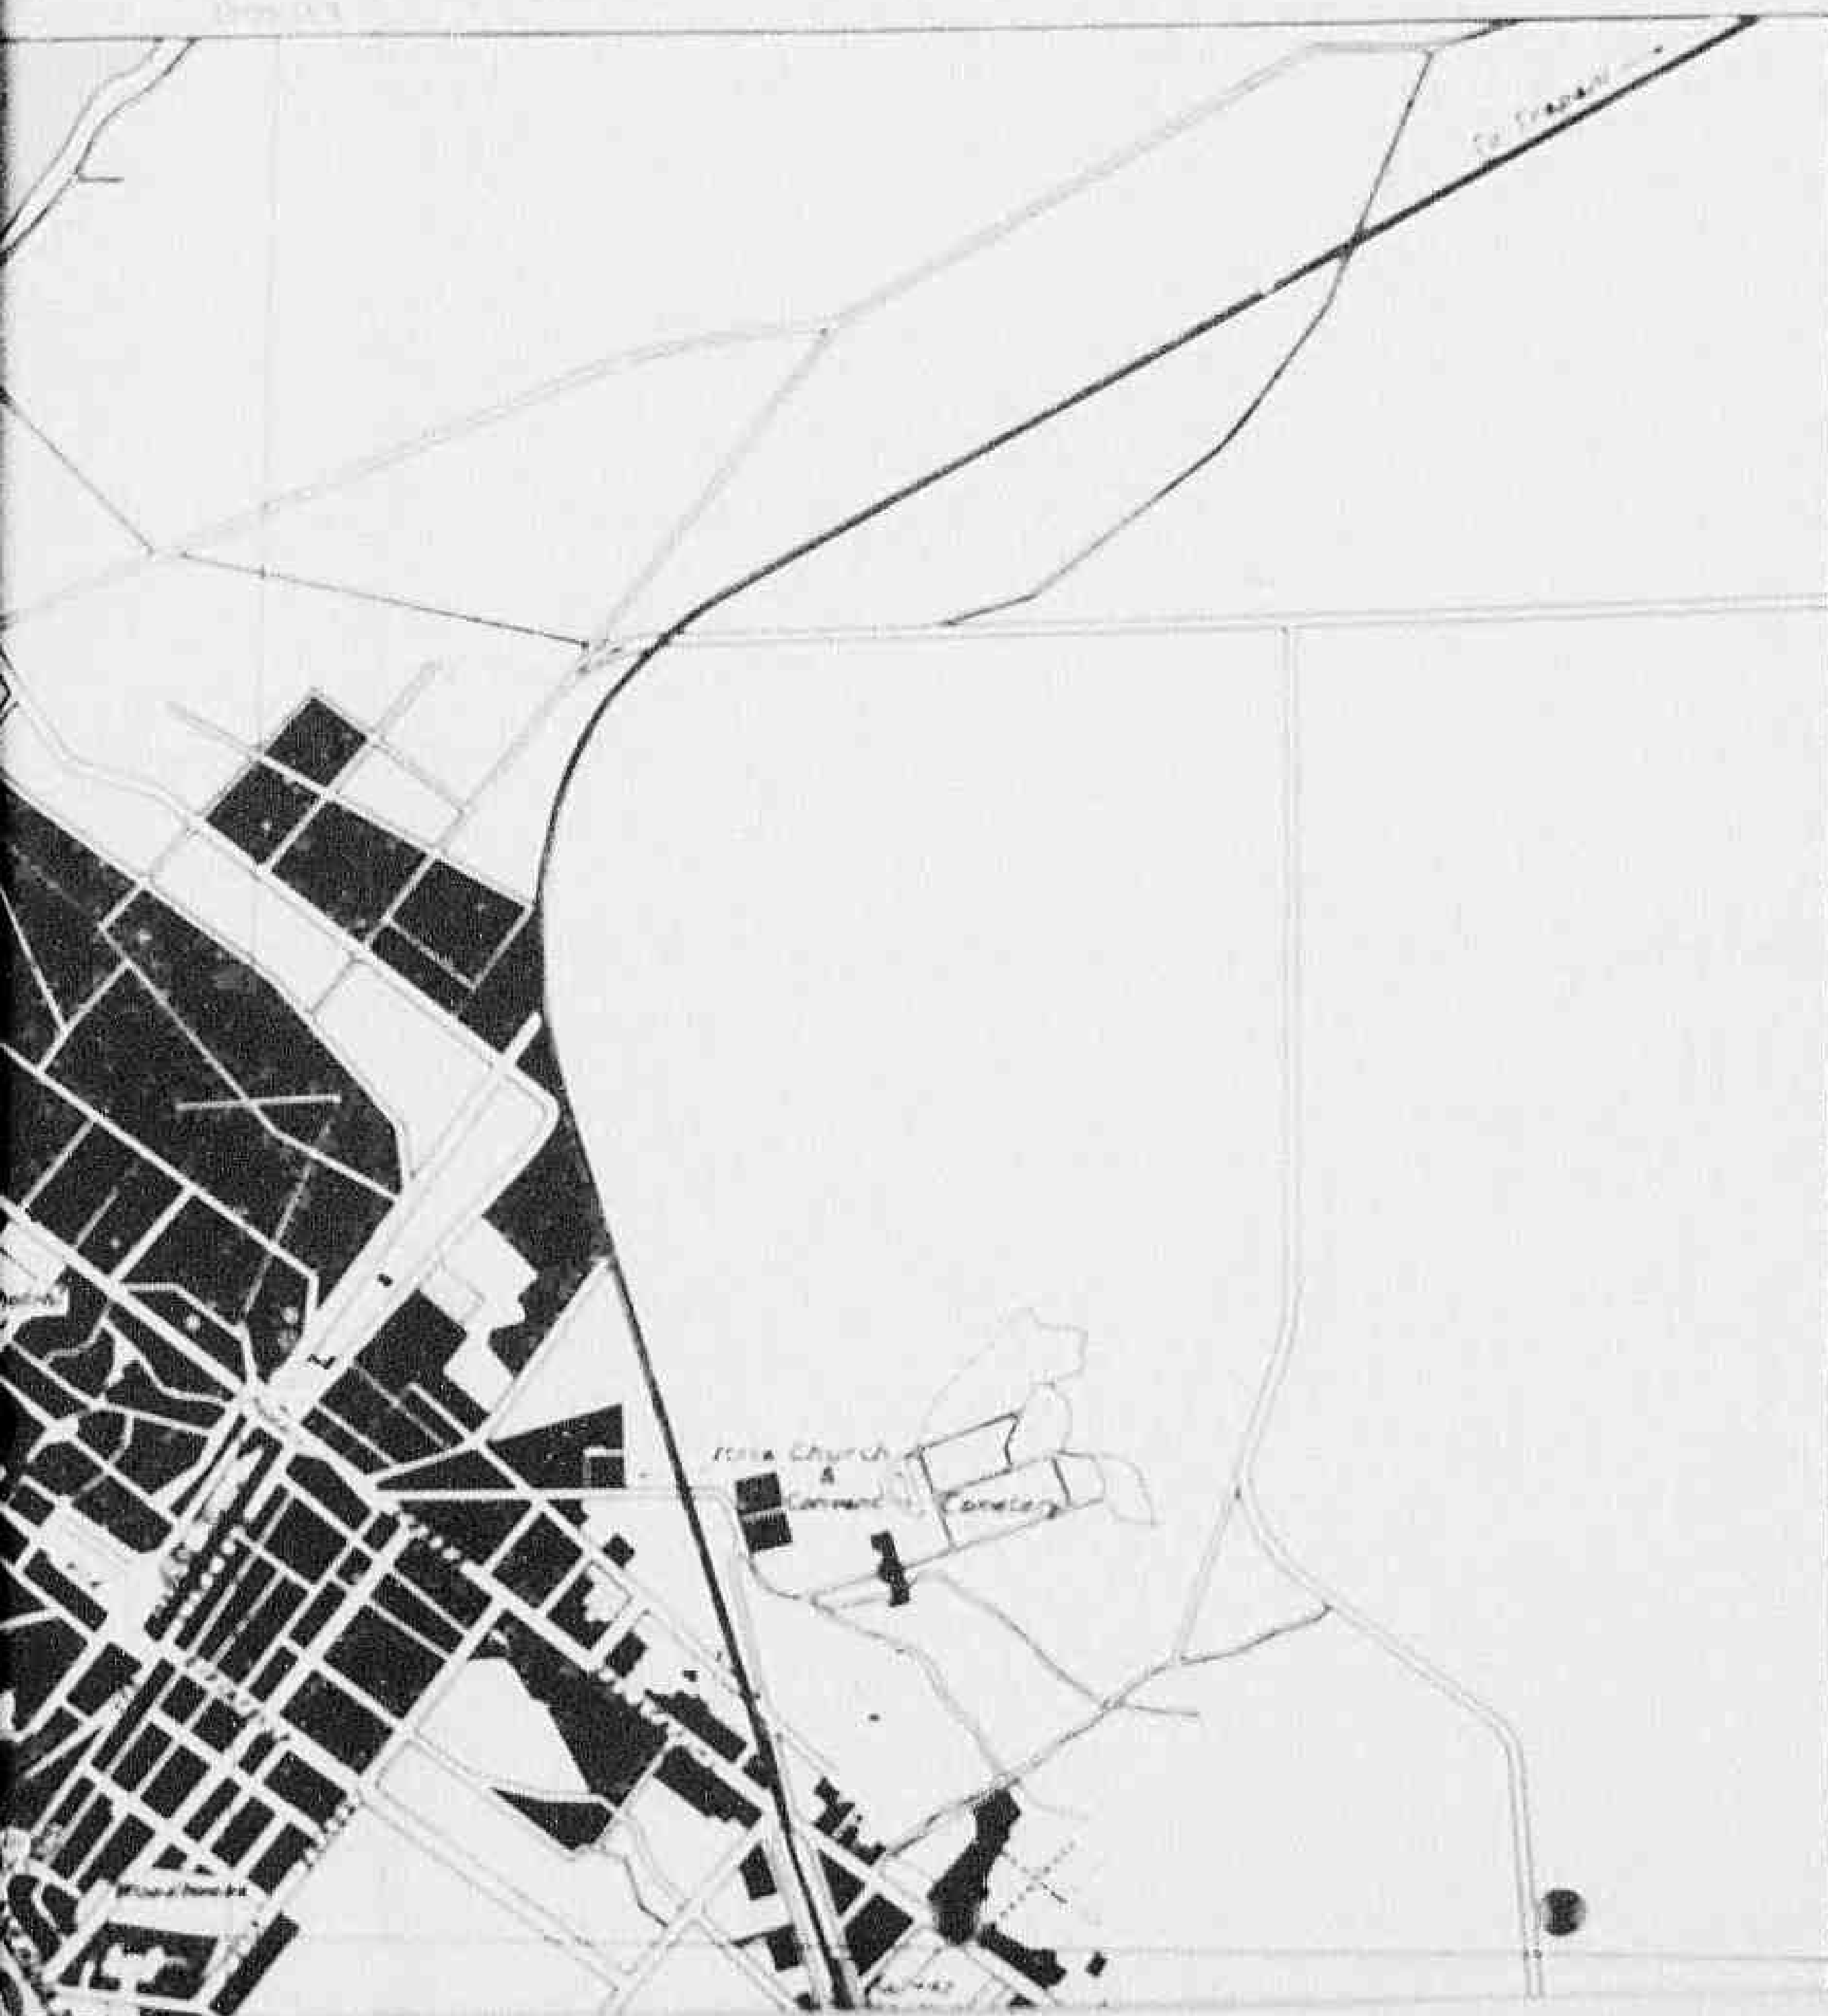
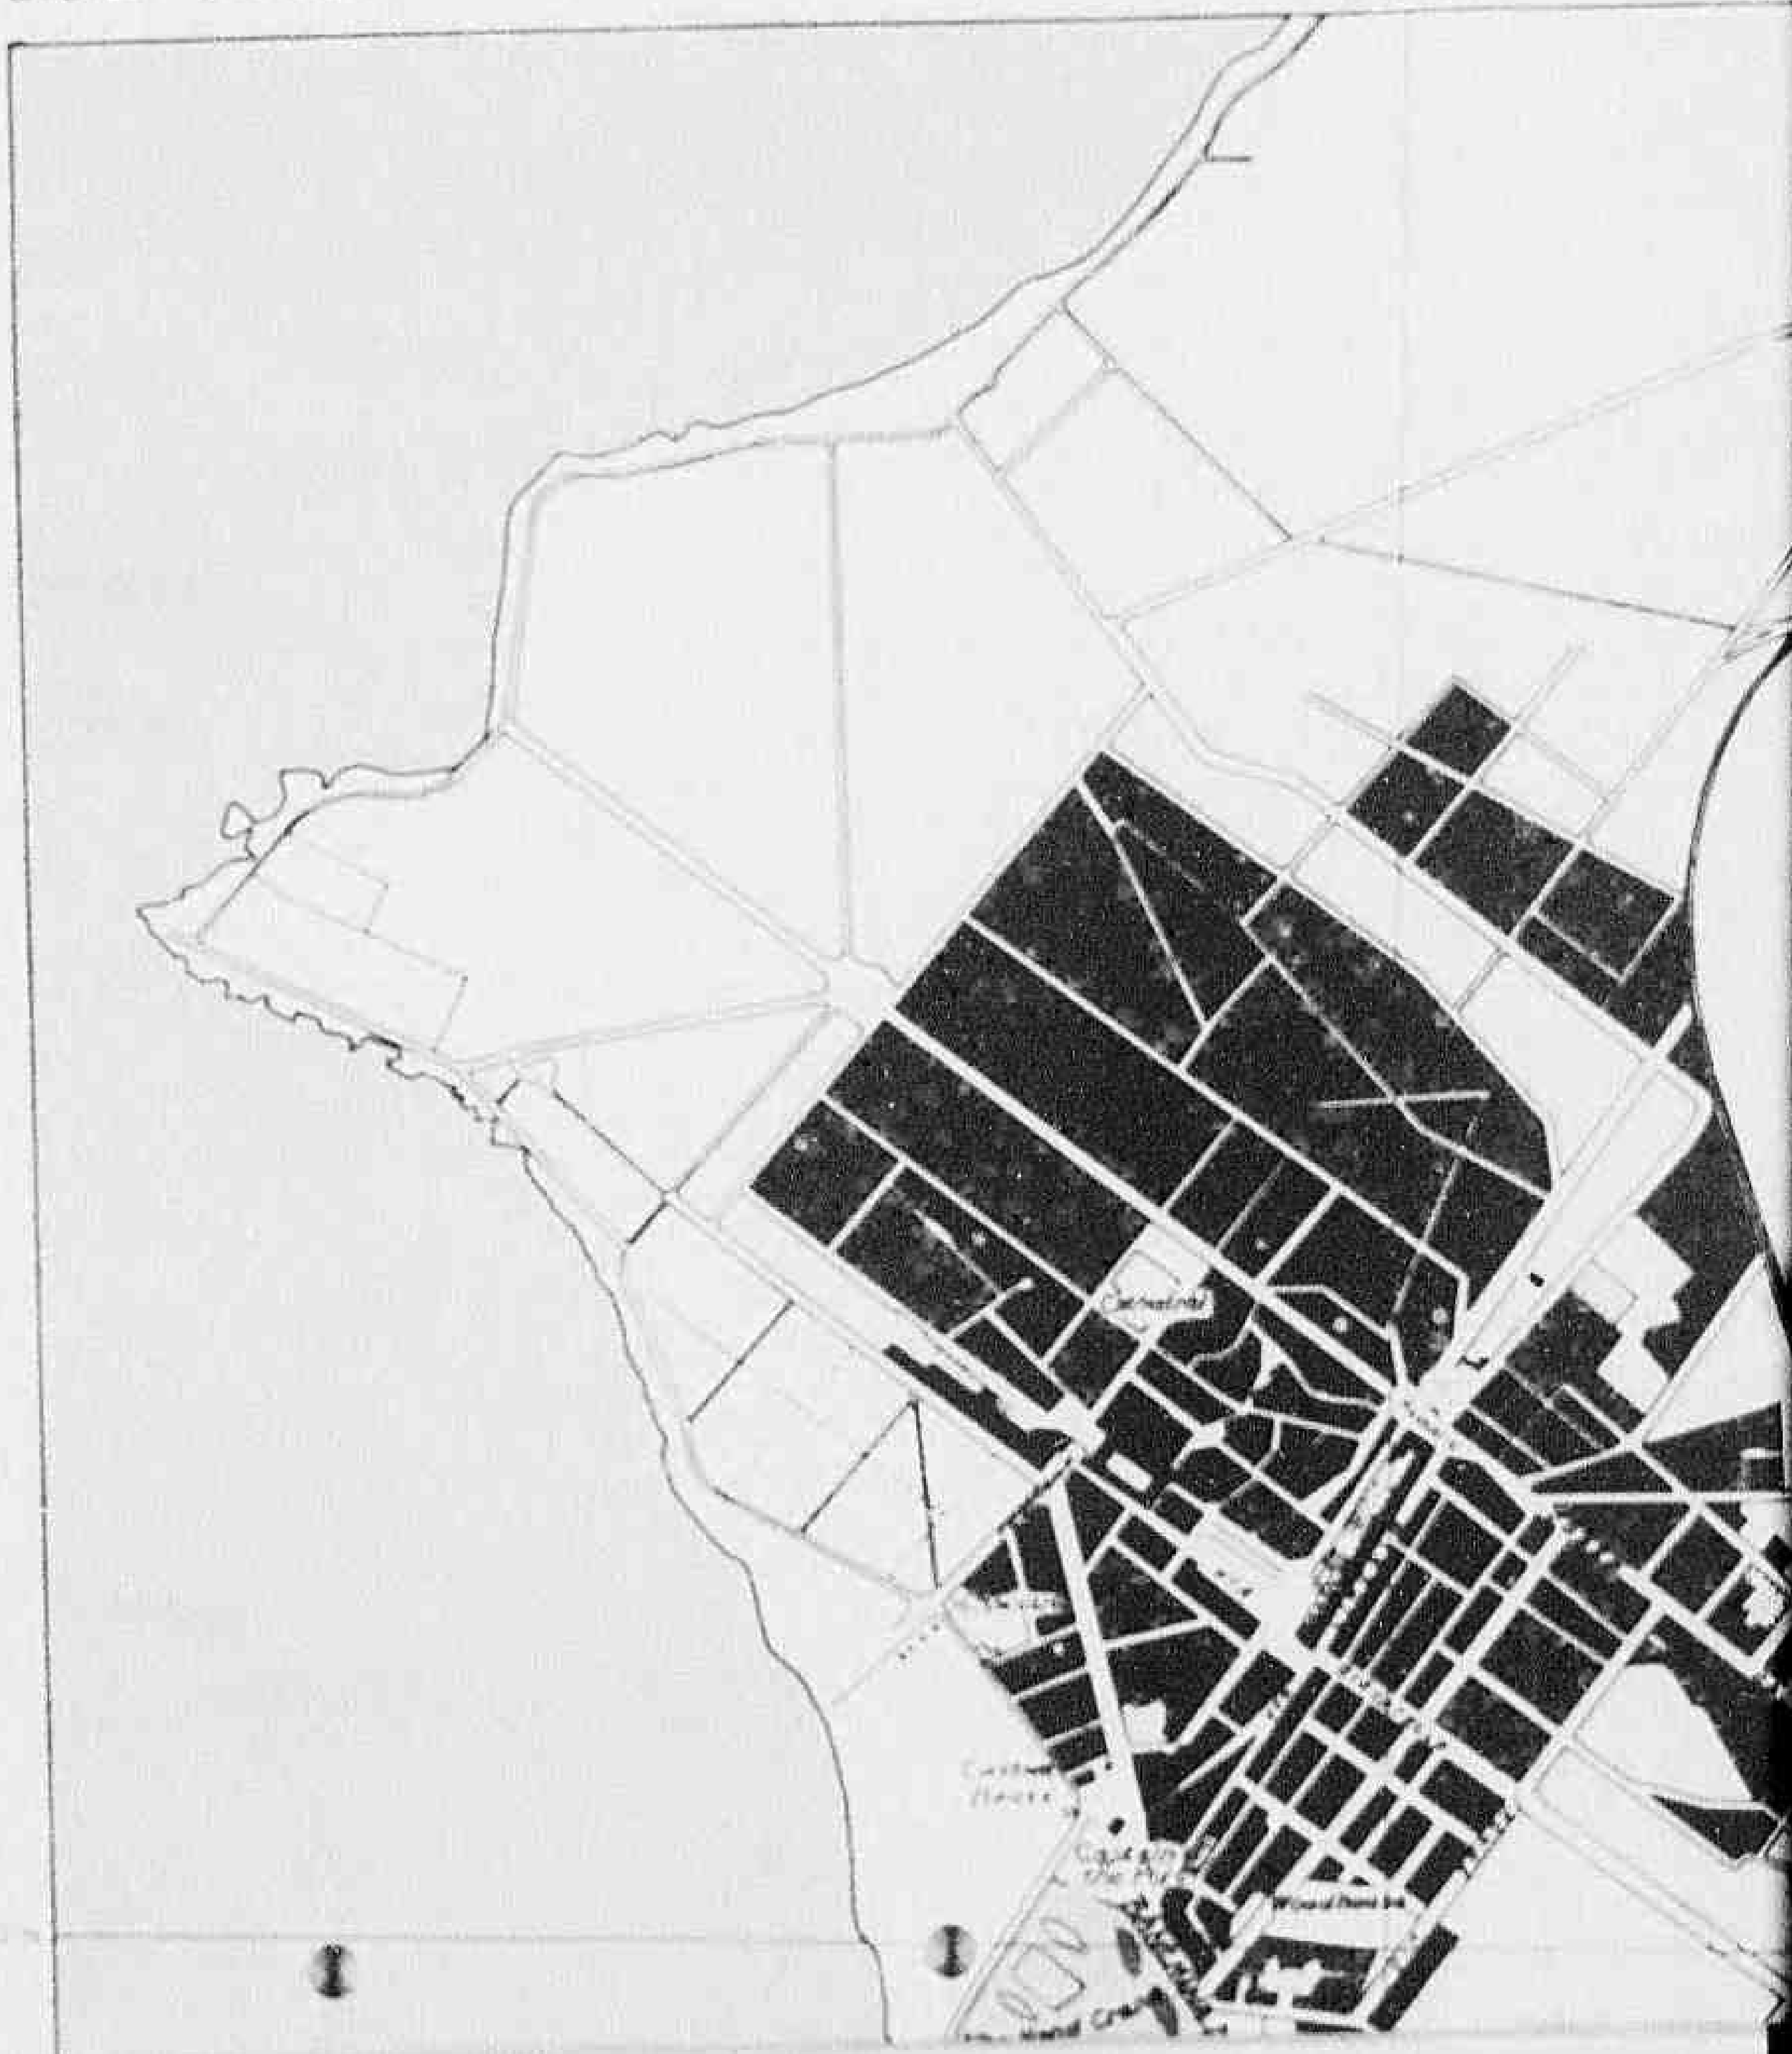
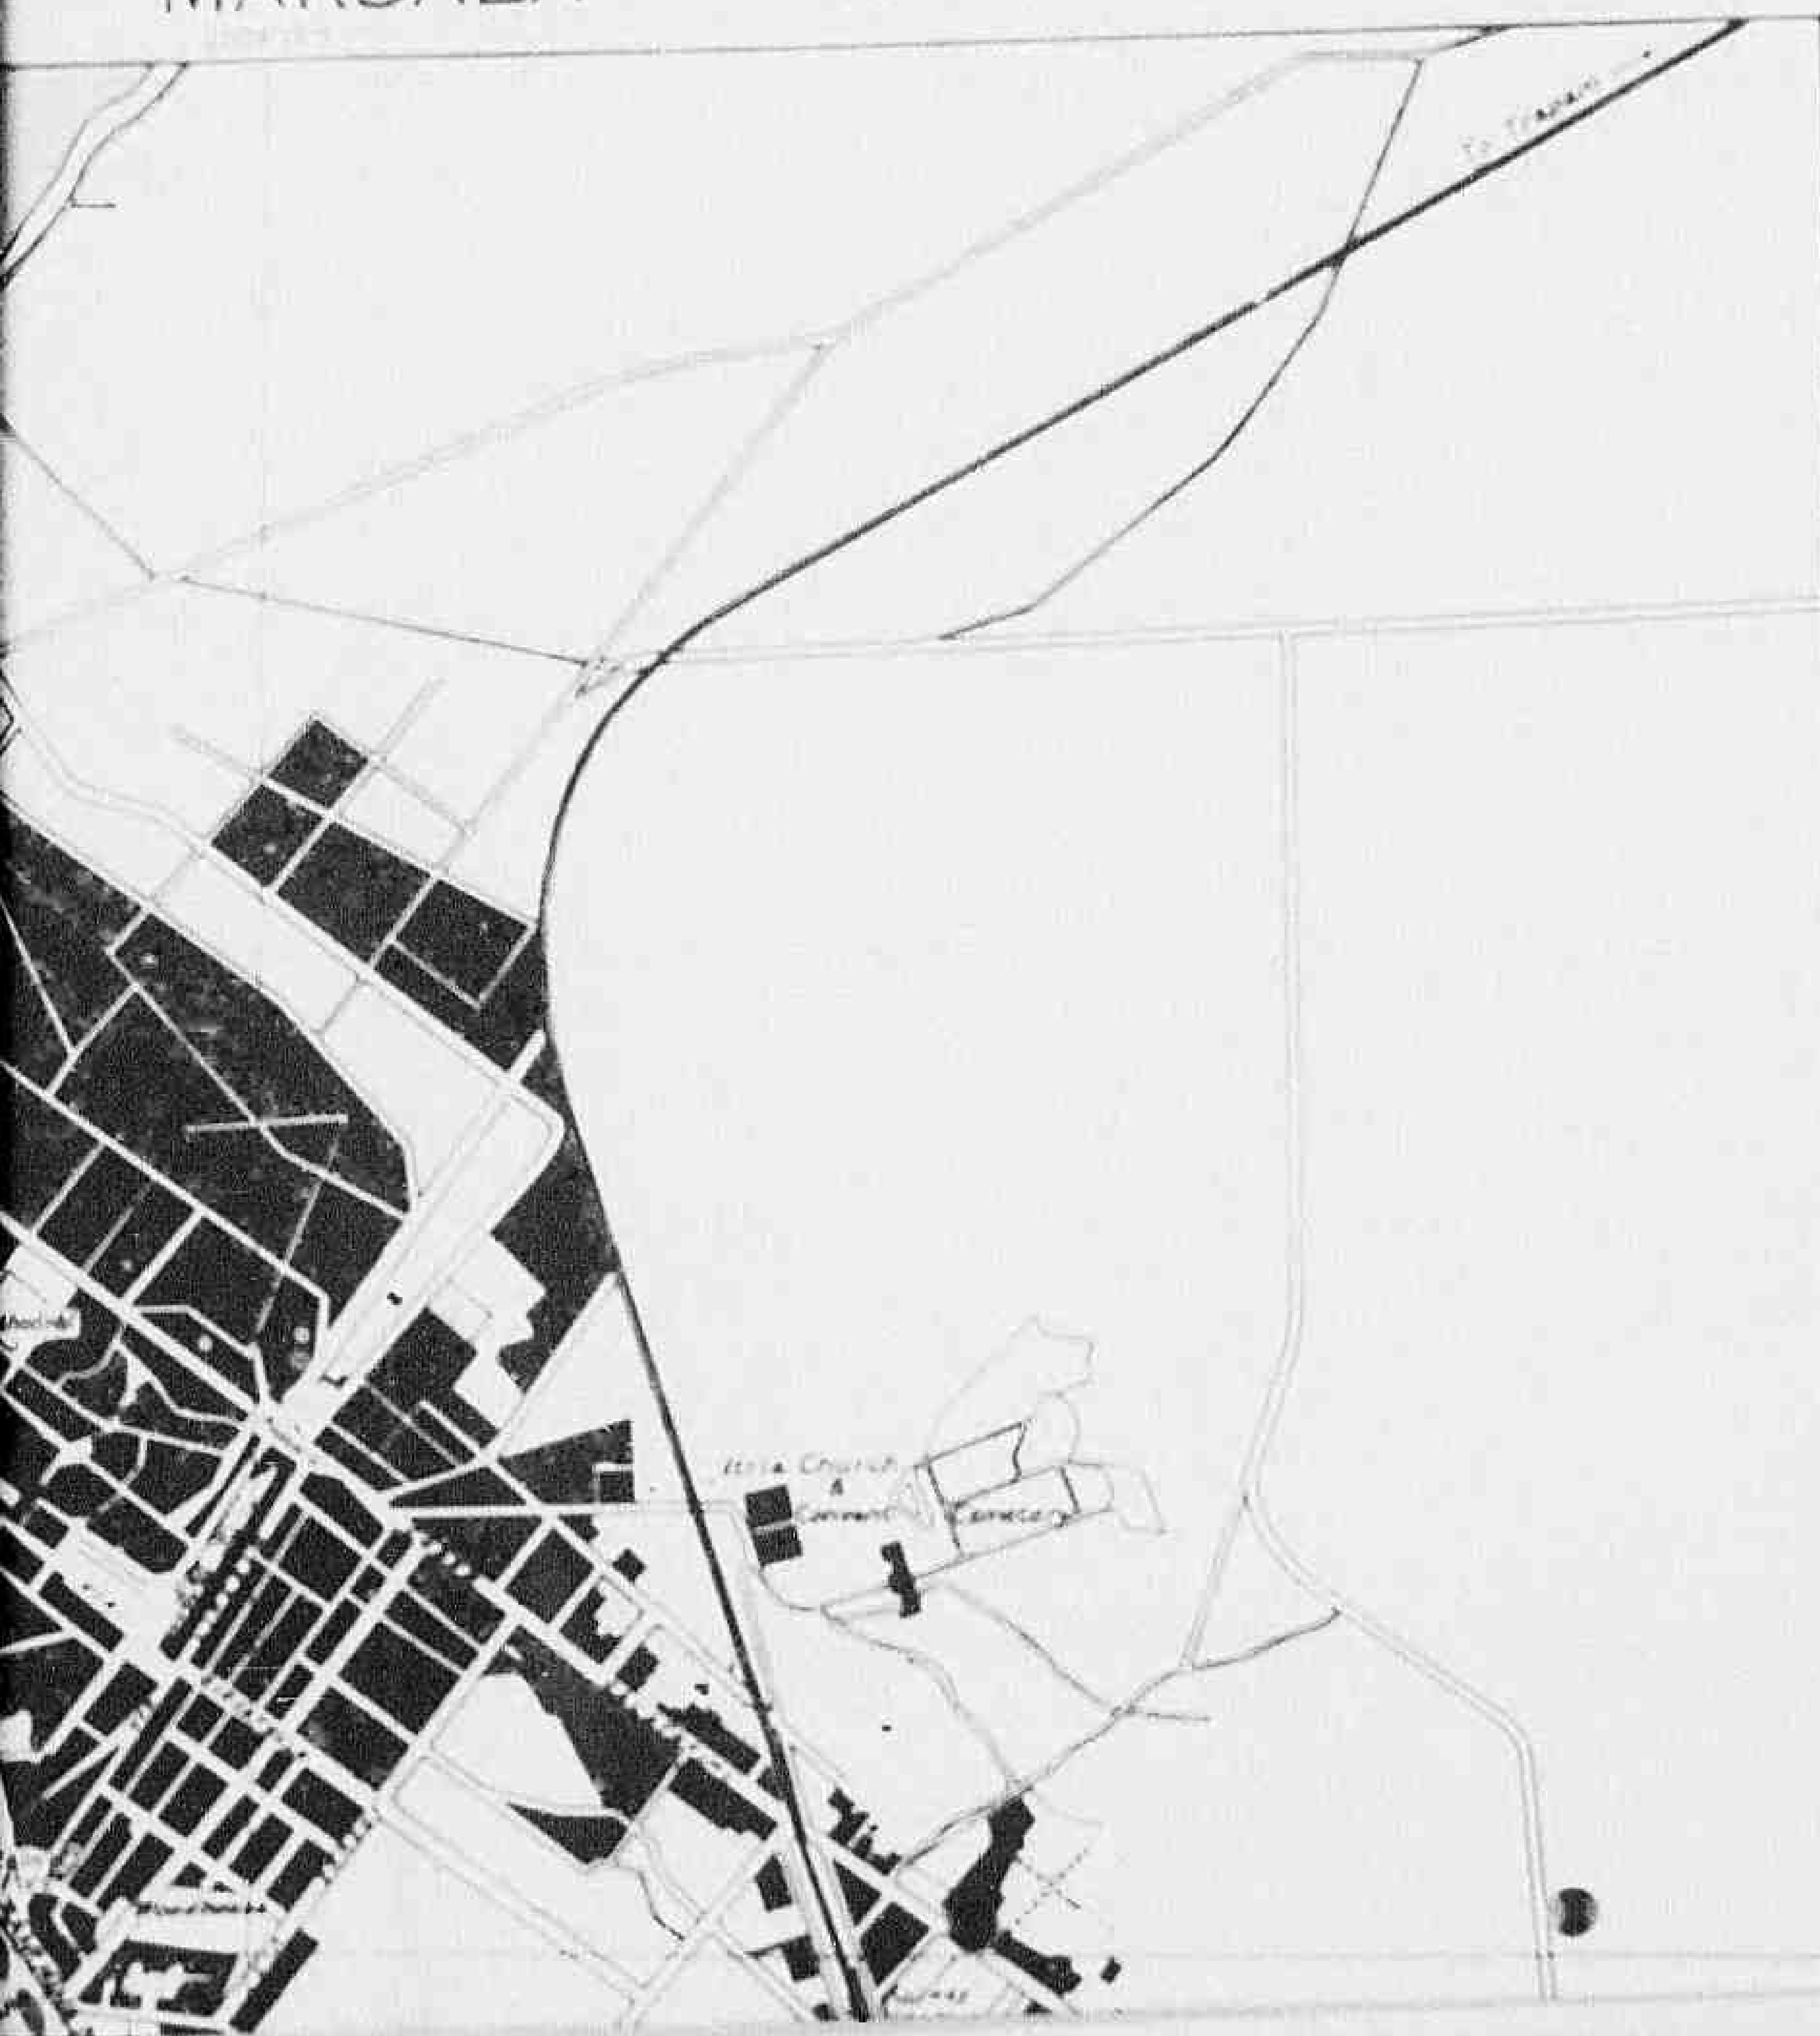
# MARSALA

CITY PLAN

Repairs to the wharves 1, 4 and 5, as indicated on map, are obligations of the Italian Govt.
